Structural engineering observations from the 26 November 2019 M_w 6.4 Albanian earthquake

A.W. Charleson

ABSTRACT

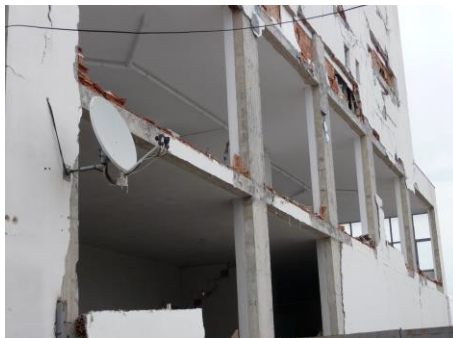
Although we have described the most prevalent structural system as a reinforced concrete frame and infill, the description is inaccurate for two reasons. And both reasons explain why the medium- to high-rise buildings observed were so flexible under lateral load. First, one of the prerequisites of a structural frame is that it possesses beams. In the majority of frame buildings observed there were no beams other than those within the depth of floor slabs (Figures 5 and 6). Generally, these slab-beams were 300 mm deep and although adequate to carry gravity loads for spans around six metres, the “frame” is very flexible. It is surprising that such a frame could meet code lateral deformation requirements? Beams at least 600 mm deep would normally be expected. At least one structural benefit of using such shallow beams is that columns are stronger than the beams, in accordance with the principle of Capacity Design.

Figure 5: Fallen infill panels reveal beams no deeper than slabs

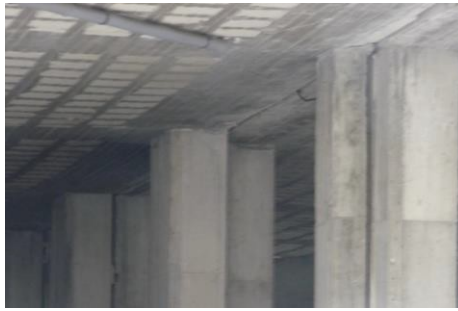
Figure 6: Slab-beams in the first floor of a 12-storey frame building. Note polystyrene rather than hollow clay brick infills.

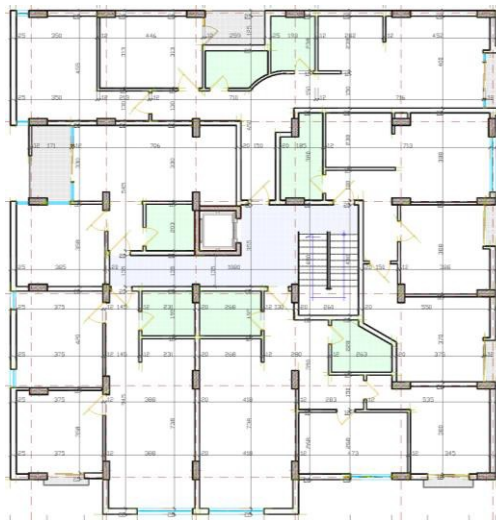
The second inaccuracy in describing most of these buildings as frame buildings is the absence of regular frames. As illustrated in Figure 7, the problem is the irregular orientation of columns in plan. In each orthogonal direction there is only one significant frame with multiple bays where columns bend about their strong axis. All other frames have only one or two bays where column depths are orientated parallel to the frame direction. Yet again, the frames are very flexible, and this plan irregularity also introduces torsional eccentricity. Finally, with reference to Figure 7, we note a single reinforced concrete elevator shaft in plan. However, this element cannot be considered a shear wall suitable for resisting lateral load. Its large height-to-depth ratio render it extremely flexible (and weak). At least its placement near the centre of plan avoids torsional eccentricity.

Figure 7: Typical floor plan of a 10-storey building with irregular column orientation

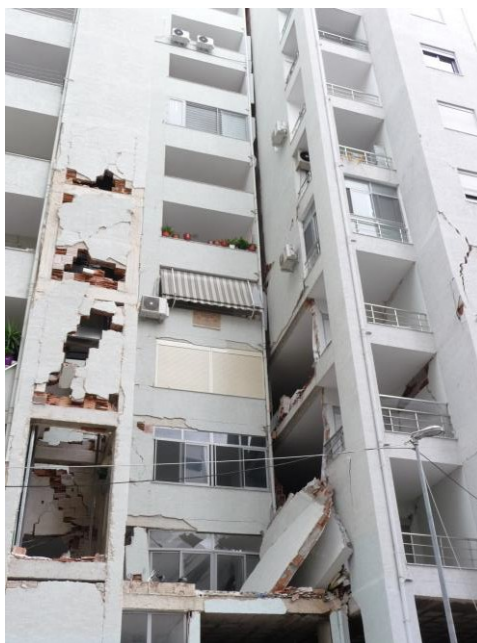
What is most striking about the damaged buildings still standing, and often uninhabited, is the extent of non-structural damage. The building shown in Figure 8 is typical of tens if not hundreds of others. Extensive damage has occurred to infills and partition walls *at the lower half of the building only*. It was confirmed by one building owner that while non-structural walls on lower floors had suffered extreme damage due to in-plane deformations and out-of-plane failure, upper floors were virtually undamaged. These buildings exhibit *soft-storeys* rather than a single soft-storey. All elastic and inelastic deformation has concentrated in up to five or fewer lower levels. There was very limited evidence of inelastic behaviour in structural members.

This observed damage in the lower floors of buildings is not entirely expected in earthquake engineering practice. According to theory, lateral interstorey deflections of frame buildings are greater near the base, but certainly present at the top of buildings, especially when higher modes are induced. Also, maximum horizontal accelerations increase with height. From a simplified perspective then, one expects greater in-plane damage due to interstorey deflections at lower floors of a building, but greater out-of-plane damage at higher levels. It appears therefore that in-plane deflection and damage has made infills and partitions more vulnerable to out-of-plane failure, and that the softening of the lower infills has created several soft-storeys that have effectively isolated the upper floors. Stiffened by their undamaged walls, these upper storeys have then acted as a rigid body above very flexible and long-period frames beneath. We hope that researchers using push-over and dynamic analyses, and by modelling all brick walls can confirm what is now only a theory.

Figure 8: Multi-storey building with extensive wall damage to lower storeys

Avoidance is the most common strategy to overcome the problems identified above. Light-weight and relatively flexible infills are one option, followed by precast panels whose flexible connections to frames are detailed to accommodate calculated interstorey drifts. Another solution involves designing the primary structural system stiff enough to protect unseparated infills. Otherwise, if masonry infills are to be used the best strategy is to separate. A recommended detail is shown in Figure 11 (Hollings 1981).

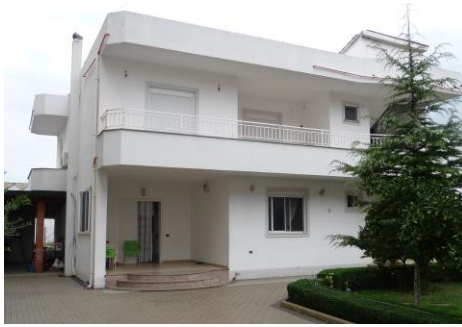
It was also noticeable how most low-rise buildings suffered no or minor damage (Figure 9). Although the primary structures have been designed as open or bare reinforced concrete frames, the infills and partition walls which are far stiffer (and stronger?) than the frames have acted as bracing walls. Given the low intensity of ground shaking, the walls have remained elastic. No diagonal tension failure was observed nor diagonal compression forces great enough to damage the tops or bottoms of columns. This latter failure mode was observed in just one building in which the infills were of solid bricks. Neither have walls fallen from their frames to which they are so unreliably attached. For this low-intensity shaking, walls have unintentionally functioned like the bracing walls of Confined Masonry houses.

Figure 9: An undamaged house adjacent to a badly damaged building

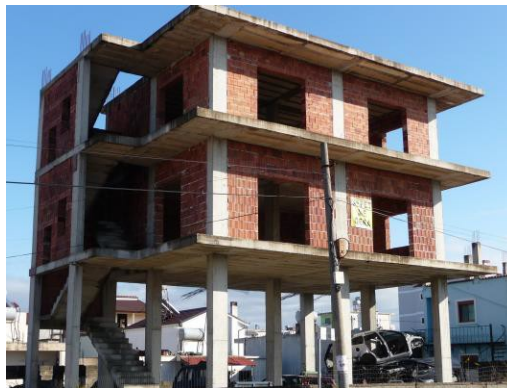
Another type of non-structural damage observed was to seismically-unseparated reinforced concrete stairs. Figure 10 illustrates a typical example. The lowest stair landing and its supporting beam was cracked. This damage may have prevented more serious damage that could have occurred due to torsional eccentricity caused by the unseparated stairs. Otherwise the structure and infills appear undamaged. Possibly the flexibility of the infill due to no mortar in vertical joints between bricks and before plastering reduced the demand on the soft-storey ground floor columns.

Figure 10: The lower stair landing on the left-hand side is damaged by unseparated stair flights acting as inclined struts in one direction and as elements in bending and shear in the other

Separation is the recommended strategy for preventing concrete stairs both becoming damaged or damaging the primary structure. Provision of separation, which in practice is very simple, must be made to prevent stairs trying to resist interstorey drift in any horizontal direction. For details, refer to Charleson (2008).
