Monitoring of lateral stiffness changes for a real building using hysteresis loop analysis

M. Rabiempour, J.G. Chase & G.W. Rodgers

University of Canterbury, Christchurch.

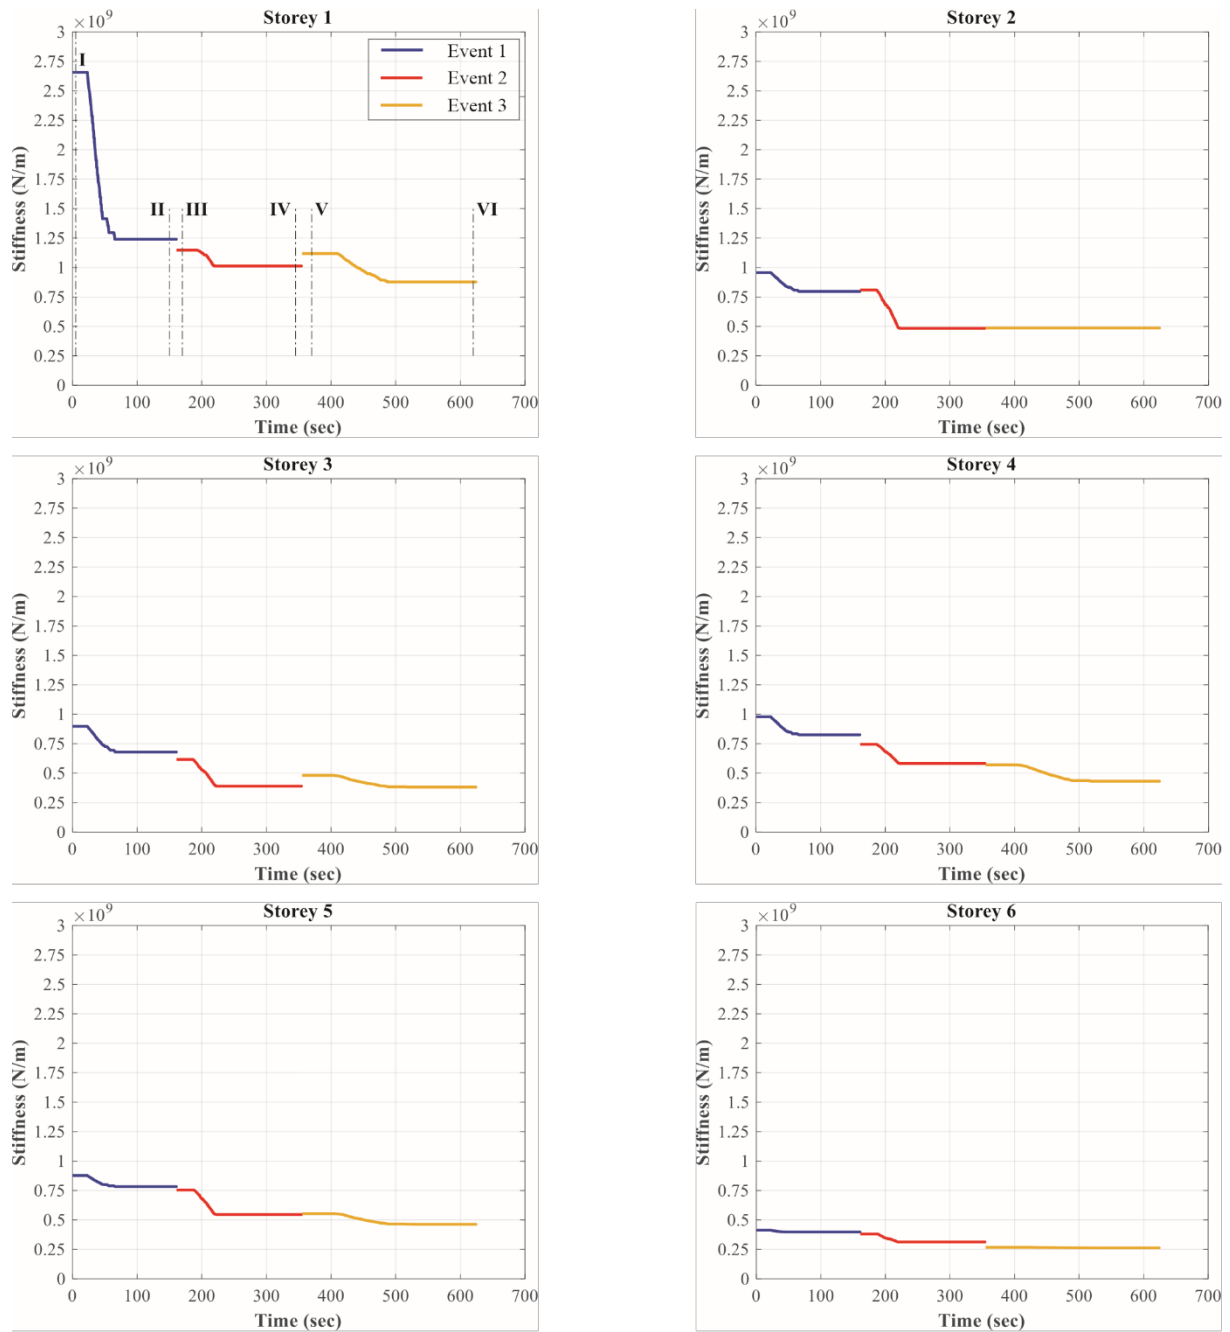
Figure 5 shows changes of lateral elastic stiffness, K_e , in the building for the three earthquakes. The stiffness values at stages I-VI are summarized in Table 2, showing small differences between the stiffness of stages II-III, and IV-V.

There is the appearance of some inconsistency between events in Figure 5, particularly for storeys 1 and 3. These increases can be due to retrofit, where no specific documentation was found. However, it is also important to note checking agreement across two uncertain identified values using a relative error of 12% for these measures of displacement (Skolnik 2010) shows these estimated values have intersecting ranges, which means they are in agreement. All other results show very good continuity. This level of continuity has only been demonstrated, to date, by HLA in highly controlled scaled (Zhou 2017c) and full-scale tests (Zhou 2019, Zhou 2017b). These results are the first in an instrumented as-built, real-world structure under large earthquakes.

Damage percentages in Table 3 shows how destructive the first earthquake was for the building. Moreover, it is clear the second event was considerably destructive. On average, the BNZ building was damaged more than 40% due to the first two events, despite reports of only superficial damage (Chandramohan 2017, SCHOUTEN 2014, Stuff 2013, Thomson 2014). The maximum degradation occurred in the first storey with a 67% drop. The average stiffness drops across all storeys were 24%, 21% and 9% for each event, respectively.

The stiffness evolutions in Figure 5 reveals no significant structural retrofit happened in Unit 3 after the first two events. If done, it was not enough to improve its behaviour for the future event. This outcome matches reports of only superficial damage after these two events (Chandramohan 2017, SCHOUTEN 2014, Stuff 2013, Thomson 2014). HLA results show major damage after events 1 and 2 requiring major retrofits. However, the building did not receive them because the severity of damage was not identified and no change is seen in structural stiffness afterward before events two and three. At the end, the building had to be demolished less than 10 years into a normal 40-50-year lifecycle, where several of these years was unoccupied, creating a larger economic loss imposed on owners due to a lack of accurate information on the building status.

Figure 5: Elastic stiffness evolution captured by HLA for the three events with stages I-VI shown in the plot of Storey 1.
