Innovative seismic upgrade of Left Bank Art Gallery, Greymouth.

J.R. Mackenzie

Elmac Consulting Limited, Christchurch, New Zealand

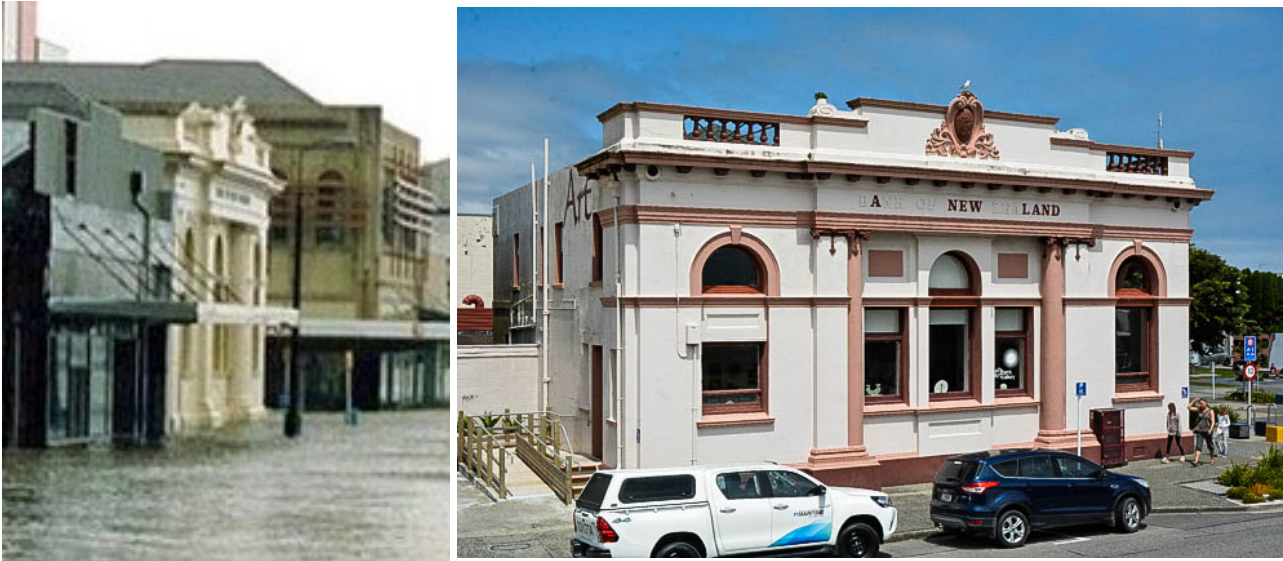
Figure 2 (left): North wall of the Art Gallery viewed from Mawhera Quay, photographed in 1988.

Figure 3 (right): As above, photographed in 2020.

Prior to strengthening, the URM walls would likely be heavily damaged in the event of significant earthquake-induced shaking. In the case of a maximum credible earthquake event, the former bank building could partially collapse from torsional effects, in response to a more substantial eastern end of the building moving comparatively less than the more flexible western end of the building.

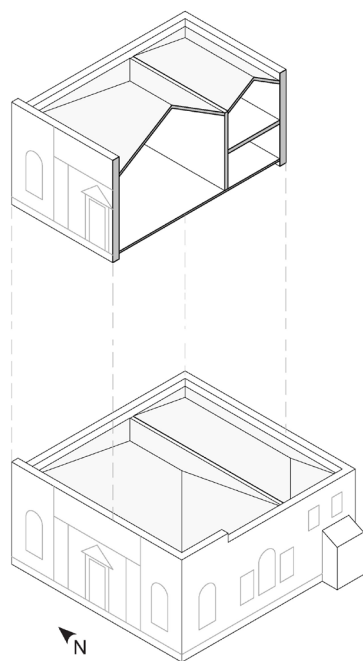
Figure 4: Architectural sketch of building layout.

The concept of the design was to construct inverted moment resisting portal frames (north – south orientation) and half portals for the east – west orientation. The frames consisted of well-reinforced “ground beams” cast directly under the original timber framed floor and “mullions” cast into recesses created on the inside of the triple-wyth external walls. This had the effect of concealing the mullions and therefore retaining the original wall lining alignment. The inverted moment resisting portal frame, together with the portal frame over the main entrance combined to provide sufficient strength in the north – south direction at the west end of the building.

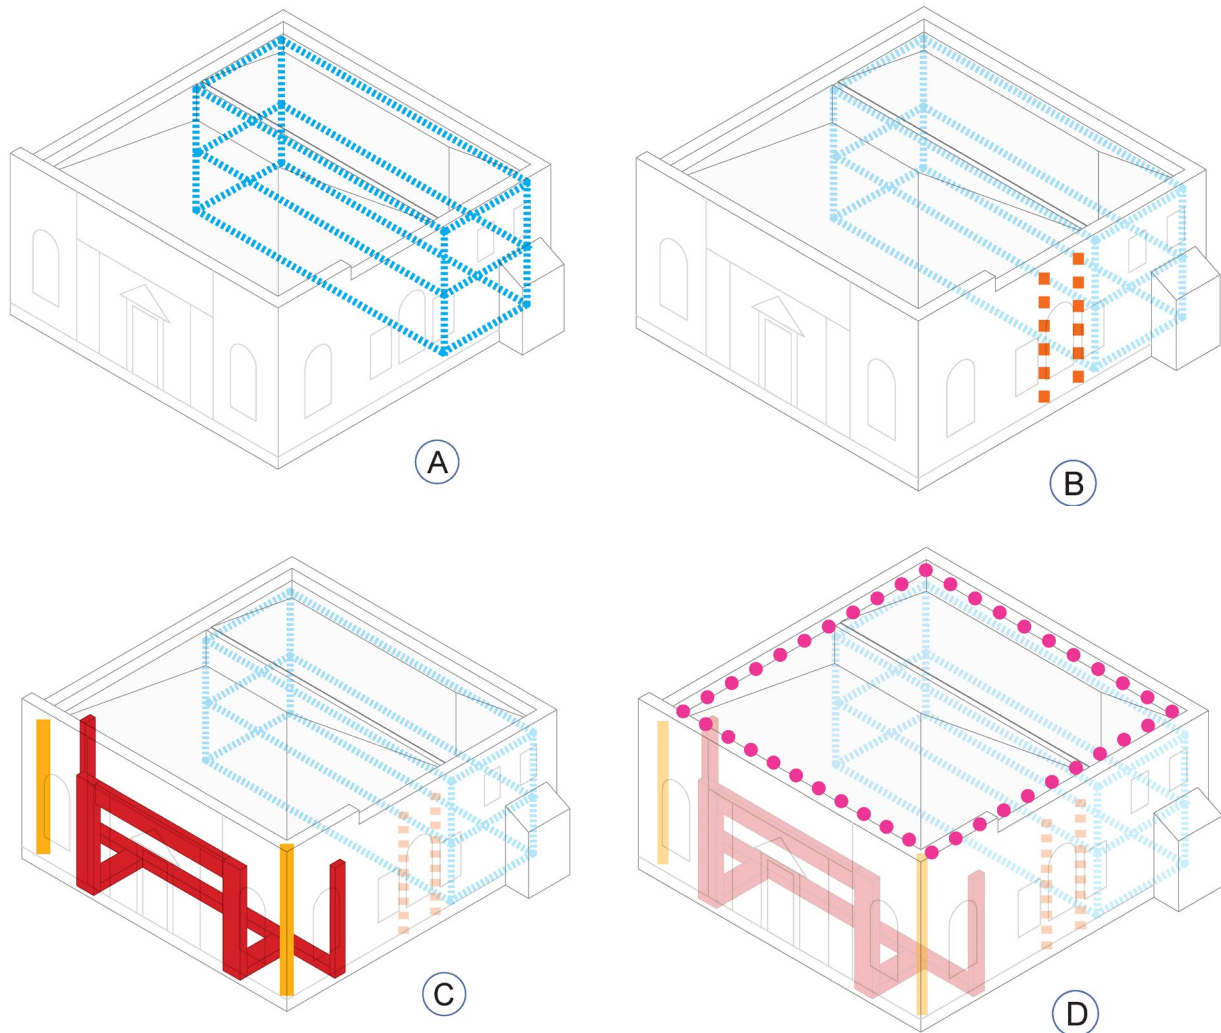
Figure 5a: The steel skeleton “cage” system installed on the inside of all brickwork in the two-storey section of the building.

Figure 5b: The secondary strengthening system shows the reinforcement of the URM walls with mullions between the windows along the north and south facing walls.

Figure 5c: The primary strengthening system shows inverted moment resisting portal frames oriented north south and over the main entrance.

Figure 5d: Steel brackets connect the roof to the top of the reinforced masonry walls.

The two storied portions of the Art Gallery building were found to have retrofitted “strap and lined” lining with minimal heritage significance. This lining was removed to enable a steel angle “cage” system to be installed on the inside of all exterior and interior brickwork. This steelwork was used to tie the walls to the ceiling/roof and floor diaphragms. Additionally, steelwork tied the first-floor diaphragm to the robust concrete safe under the west end of the two-storied area.

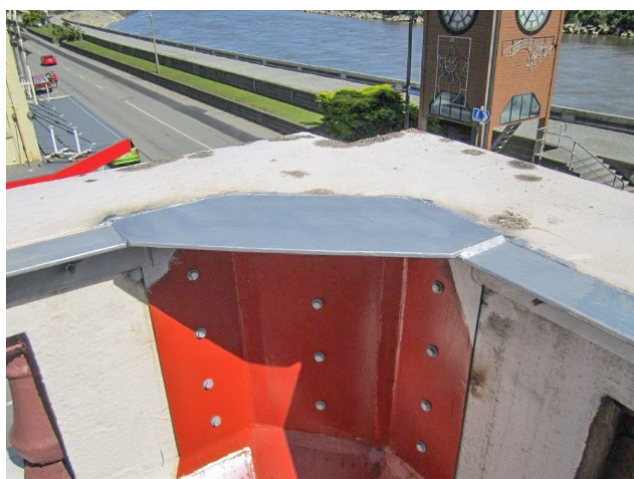
Figure 6 (left): Steel plate corner bracket and horizontal angle girts.

The first strengthening improvements “*Stage 1*” were designed by the author and comprised reinforcing the brick parapets. Horizontal steel angles were attached to the inside perimeter of the parapets on the four sides of the building, which in turn were laterally supported with steel pipe strut / “tie backs” into the roof framing. Pipe stays were installed as close to horizontal as possible to negate vertical tension forces on the unreinforced masonry parapet. The underlying timber roof framing was strengthened with the addition of numerous angle brackets to improve joint strength between purlins, rafters and the heavy timber roof trusses.

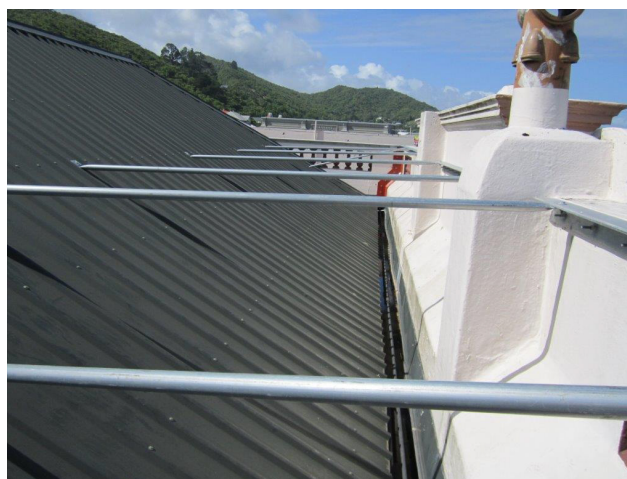
An investigation of the roof carried out in 2013 uncovered perimeter tie rods installed after the 1968 Inangahua Earthquake; however, these were corroded and needed to be replaced. The building's URM parapets were assessed as vulnerable to seismic shaking as has been well-documented in central Christchurch during the 2010-11 earthquake sequence.

Figure 7 (right): Pipe stays tie back unreinforced masonry parapet to roof bracing diaphragm system.

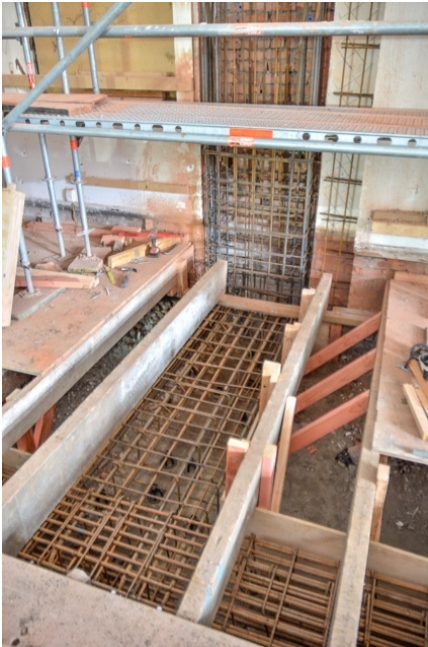
Figure 8: Sufficient monitoring took place to ensure that critical details such as beam column joints were correctly reinforced.

The implementation of the strengthening strategy proceeded substantially as planned due to the extent of the research carried out prior to construction, resulting in very few unexpected problems. Sufficient monitoring took place to ensure that critical details such as beam column joints were correctly reinforced.

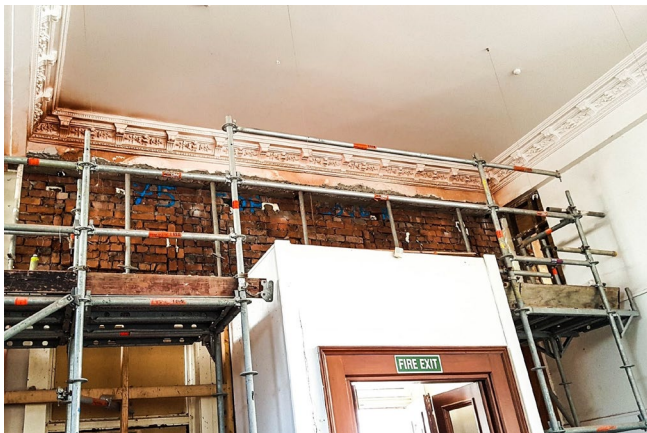
Figure 9 (left): Unreinforced masonry above the main entrance is potentially unstable in out-of-plane loading.

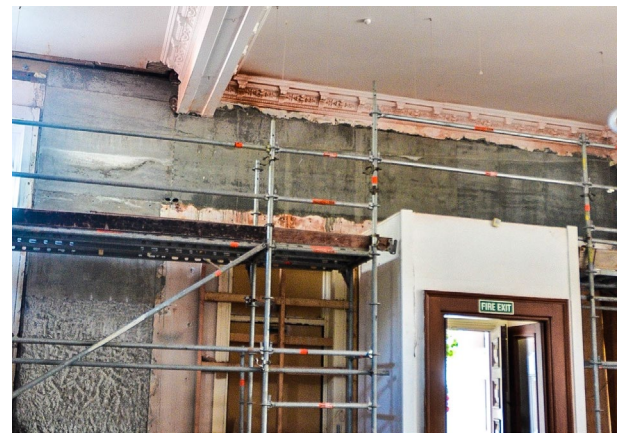
Figure 10 (right): The inverted moment resisting portal frame over the main entrance increases strength in out-of-plane loading.

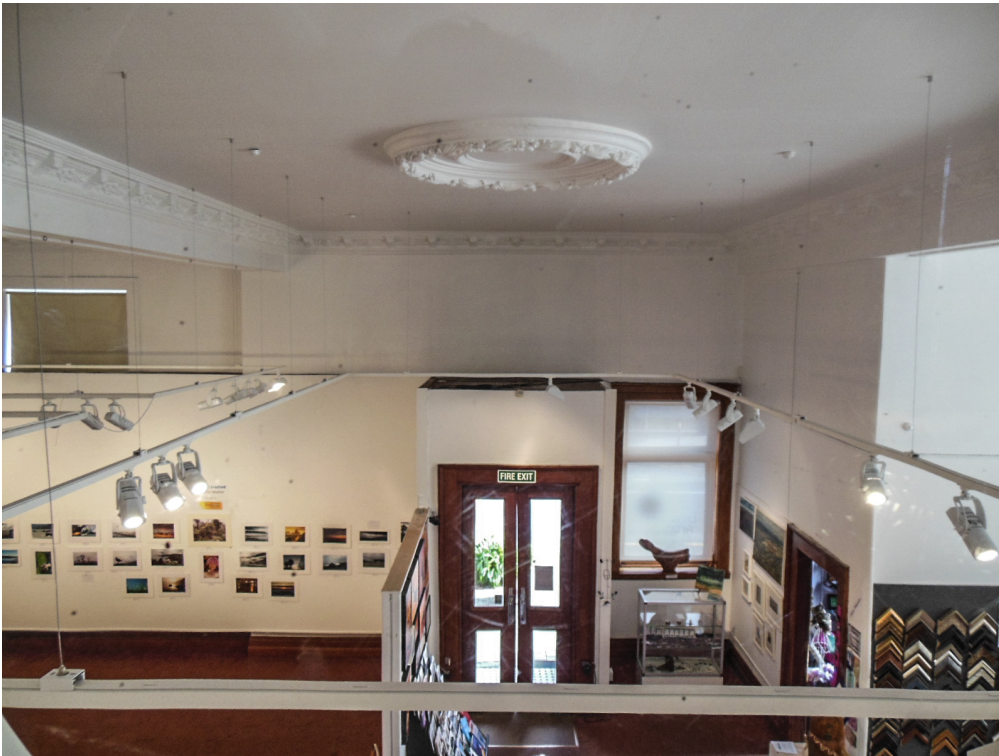
Figure 11: “Before” photo of original building prior to strengthening works being carried out.

Once the above had been carried out, the wall linings and decorative fixtures were reinstated in such a way that after completion, it was hard to tell what had changed aesthetically from the original interior. See Figures 11 and 12 for a comparison.

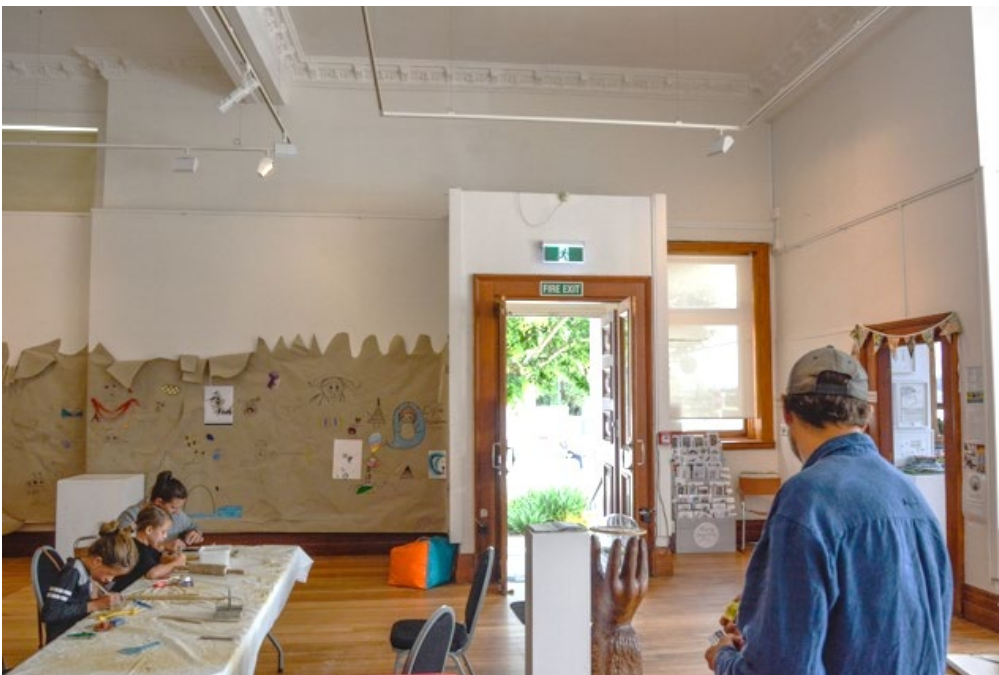
Figure 12: “After” photo of seismically strengthened building from same view.
