Seismic retrofit of historic timber structures: Uncertainties and adaption on site

M. E. Davies, G. W. Alley & A. G. Cattanach

Dunning Thornton Consultants Ltd, Wellington.

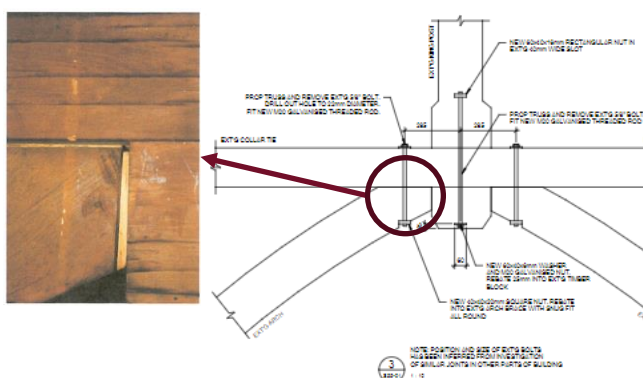
Dunning Thornton became involved with the building following the 2016 Kaikoura earthquake. Inspections and assessment after the earthquake (Clark 2016) identified that the external walls of the aisles were leaning outwards, and gaps had formed in some connections (Fig 2). The natural period of the nave and aisle structure was reported to be very long relative to other single storey structures and was within the range of periods that experienced high displacements during the Kaikoura earthquake. This theoretical flexibility matched anecdotal data of “the bells ringing themselves on windy days” and the transepts being added shortly after the original construction to mitigate swaying of the building in a northerly wind.

Figure 2: Opening of joint

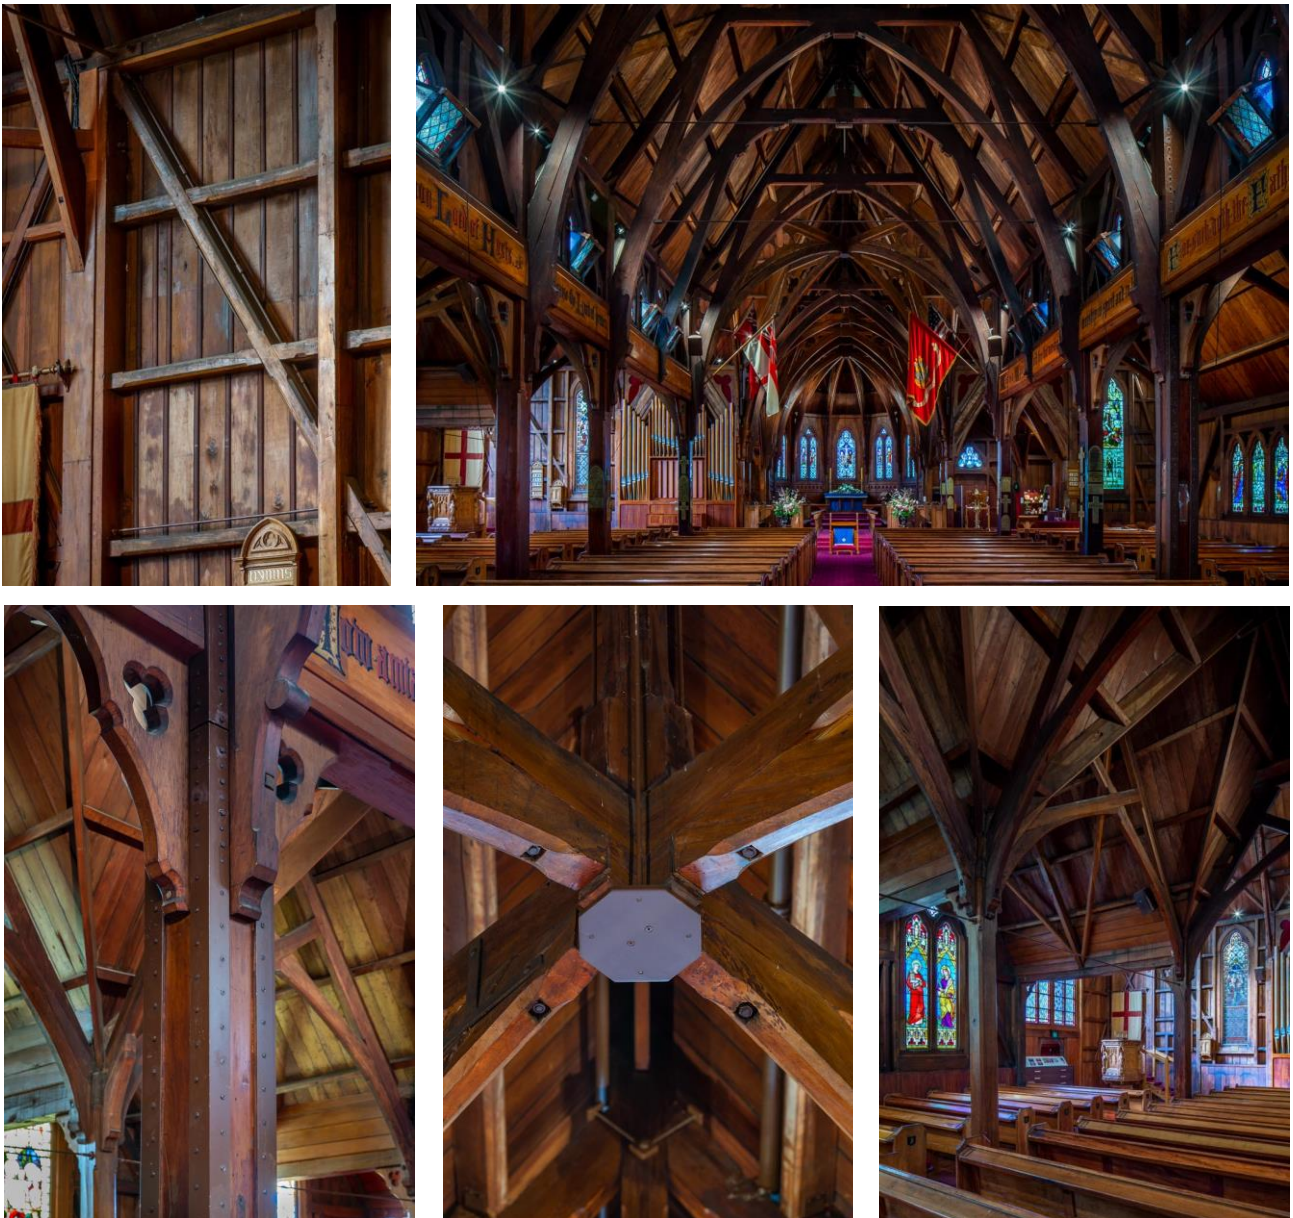
Figure 4: Clockwise from top left: new steel bars in transept wall; new transverse tie rods in aisle; new longitudinal tie rods in north aisle extension; new bearing plate in centre of crossing; repaired column in aisle.

- Two ruptured columns in the nave.
- A transept column that had been historically hollowed out to accommodate electrical cabling.
- Historic dilation and splitting of timber arches in the crossing.

Plywood templates, mocked up joints and drilling jigs were used extensively by the carpenters/joiners to finalise installation angles of dowels and self-drilling screws. This allowed Dunning Thornton to effectively pre-inspect the work and led to negligible construction defects. This sure and steady approach was especially valuable when discovering unexpected existing conditions, such as:

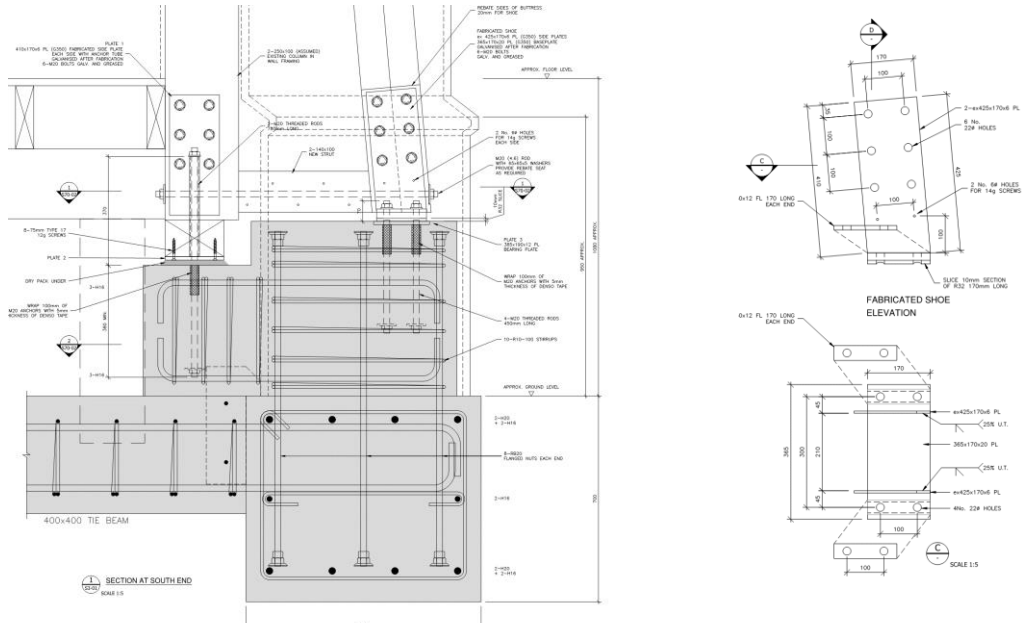
Figure 7: Ductile connection between brace and new foundation. The baseplate to the raking member can yield in two-point bending, and the hold down bolt positions are stiffened with half rounds to allow for this movement.

For the buttresses, connections were strengthened, and the bases anchored to new foundations (Fig. 7). As gravity loads were typically supported by the inner vertical elements, the outer raking members were connected to new foundations with a ductile element.

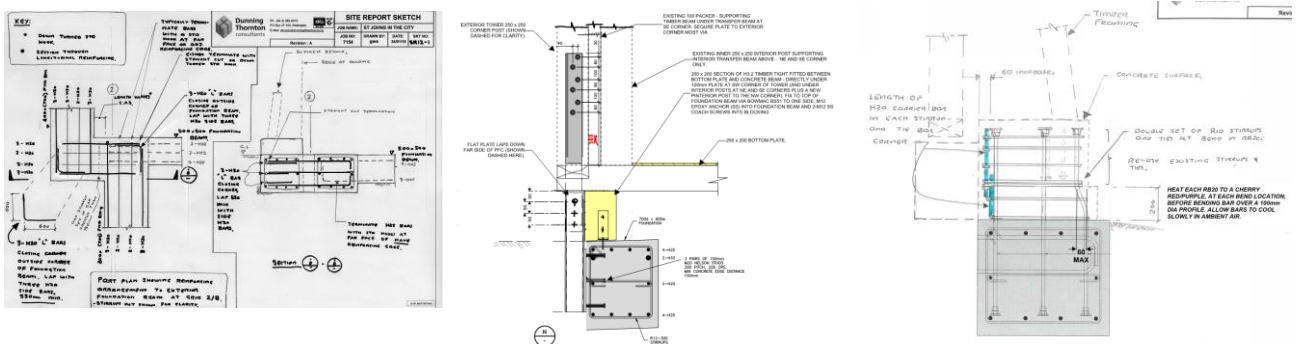
Construction was commenced late 2018 following a long fundraising period and subsequent building consent in early 2018. Significant engineering input was required to deal with arising degradation (including borer) and variation in alignments and connections throughout, lessons from which are noted below.

Figure 8: Examples of site remedial details increasing torsion demands on foundations.

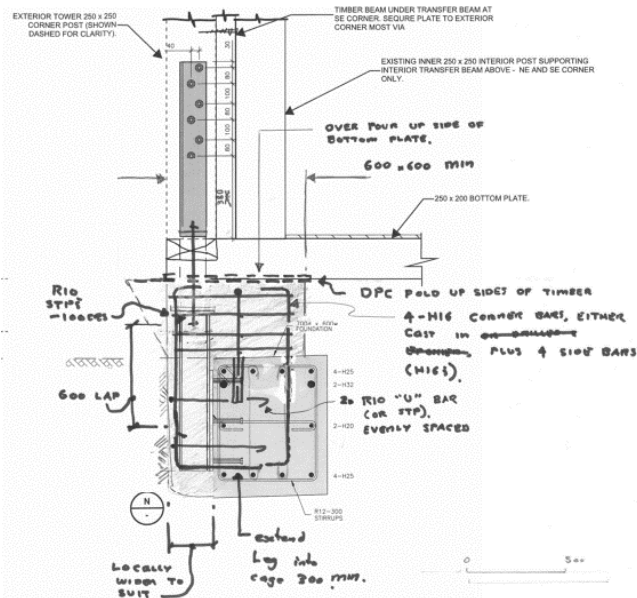
Figure 9: Example foundation rot remedial details

LVL to match strength and stiffness: deft detailing was required to maintain load paths (Fig. 9).

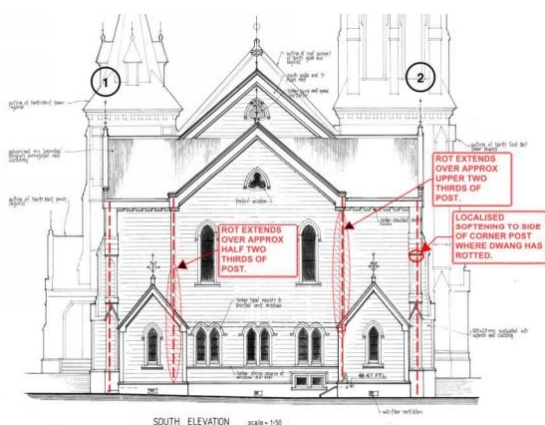
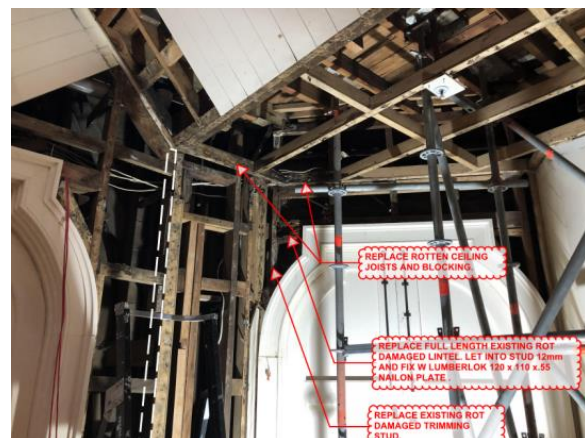
Borer was found around the gutters and internal corner details, especially towards the south wall. These were current, or more often previous, leaks where moisture content had increased sufficiently to allow borer attack (Fig. 10).

Figure 10: Example investigations and repairs

These were typically cut out and replaced where degradation was bad. Where borer had been previously treated or leaks had been fixed allowing the timbers natural dry resilience to return, core samples were taken from the wood to measure loss of density. This relatively cost-effective technique allowed the contractor to get a “feel” for assessing degradation and what areas needed to be brought to the engineer’s attention.

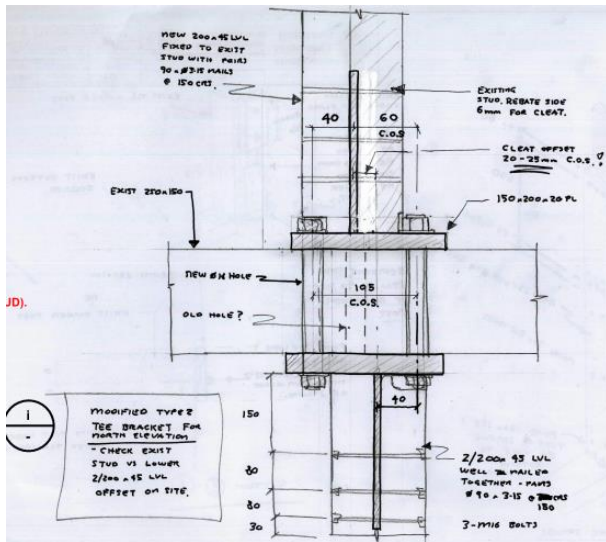
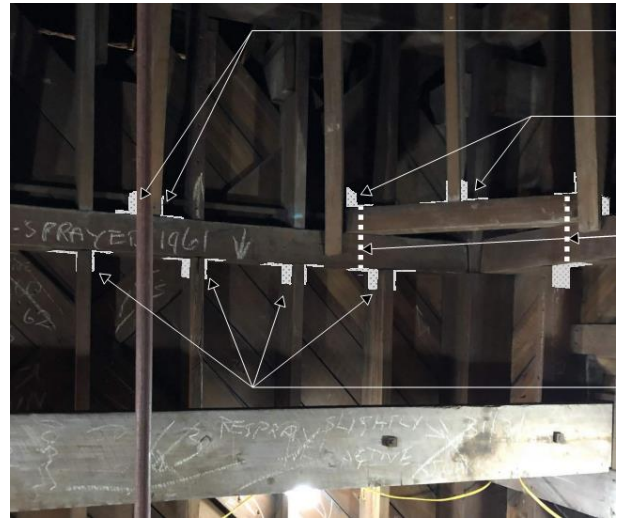
Figure 11: Example hold down alignment details.

The original carpenters were careful to align gravity load-paths for downward loads. However, load paths taking hold-down tensions, especially around windows and doors, were mixed. Again, many inventive details were required for solving these (Fig. 11), as well as a critical eye on site to spot where those discontinuities could exist where still covered.
