Testing of heavily damaged reinforced concrete walls repaired using concrete and steel replacement

G. Muñoz, R. Henry & K. Elwood

University of Auckland, Auckland, New Zealand.

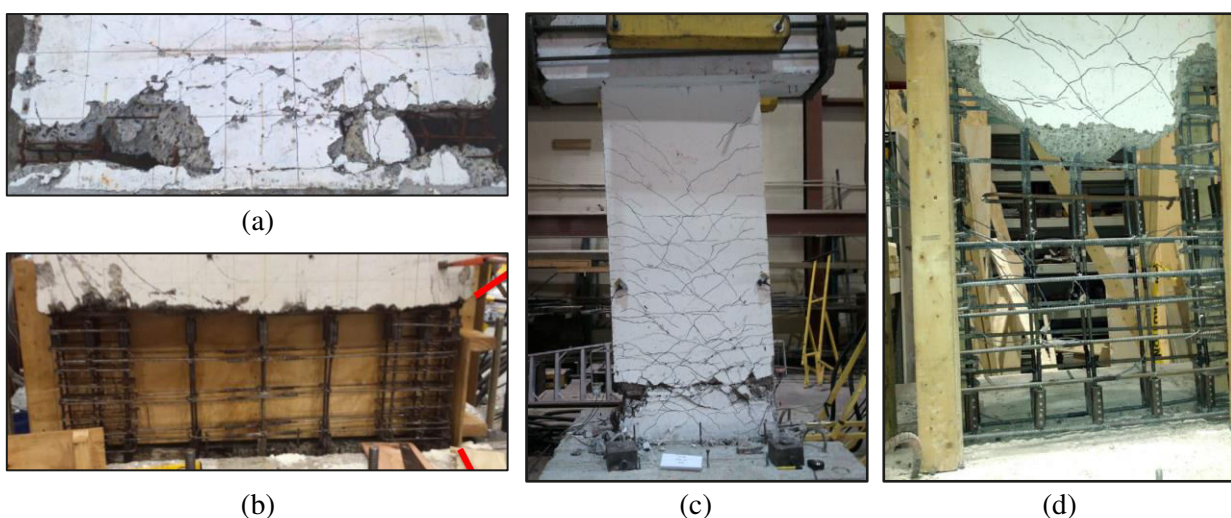
Motter (Motter et al., 2017) repaired and tested two previously damaged RC walls. Concrete crushing, bar buckling, and bar fracture were observed in the specimens, as shown in Figure 1 (a). The damaged concrete was removed, and new bars were used to replace the damaged ones. A welded connection was used to connect the new bars with the existing ones. Figure 1 (b) shows the repaired wall before attaching the formwork and pouring the concrete. A similar procedure was conducted by Cortes-Puentes (Cortes-Puentes et al., 2018) in Canada, as shown in Figure 1 (c) and Figure 1 (d). Results indicate a good strength recovery and a poor stiffness recovery. Despite a complete replacement of the plastic hinge area, the walls could not fully restore their displacement capacity.

Figure 1: Repair procedures. (a) Damage before repair in wall M5-R (Motter et al., 2017) (b) Steel replacement in wall M5-R (Motter et al., 2017), (c) Damage before repair in wall RW1-SR (Cortes-Puentes et al., 2018), and (d) Steel replacement in wall RW1-SR (Cortes-Puentes et al., 2018).

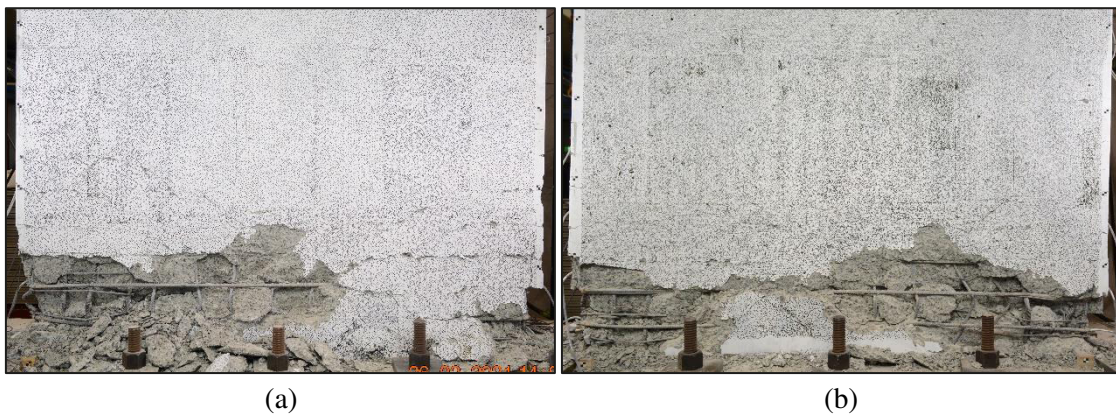
At the end of the test of walls W1C and W2D, concrete crushing, bar buckling, and bar fracture were observed at the base. The damage started in the boundary element and then propagated towards the centre of the walls. Distributed flexural and shear cracking was observed almost up to the top of the wall. Figure 2 shows walls W1C and W2D at the end of testing.

Figure 2: Damage in walls after the test, (a) W1C, and (b) W2D.

The repair of the wall started with the hydro-demolition of the lower section of the walls. The height to hydro demolish was defined to avoid the need to epoxy inject wide cracks. The walls were hydro-demolished up to the top crack with a 0.2 mm width, which was 1.2 m above the wall base. While the foundation of wall W1C was disposed of, the foundation of wall W2D was retained in the repaired wall W5D-R. Close to 80 mm of top concrete in the foundation was hydro-demolished to achieve a welded connection at the interface. All the longitudinal bars were cut, leaving close to 100 mm free for the welded connection. As described earlier, wall W5D-R used the original wall foundation, while a new foundation was cast in wall W6C-R. Figure 3 (a) shows a scheme of the walls, showing the new reinforcement and clouds around the cross-sections with a discontinuity created by the bar connections (horizontal and confinement reinforcement removed for clarity). The accessibility to reach the wall foundation in actual buildings defined the differences between these foundations. In a post-earthquake scenario, the wall ideally should be repaired considering works in the foundation, either total or partial replacement. These works would help with the strain penetration, bond slip and avoiding a discontinuity in the critical cross-section. However, in multiple cases, accessing the wall foundation is challenging and can considerably increase repair costs. A repair procedure without work in the

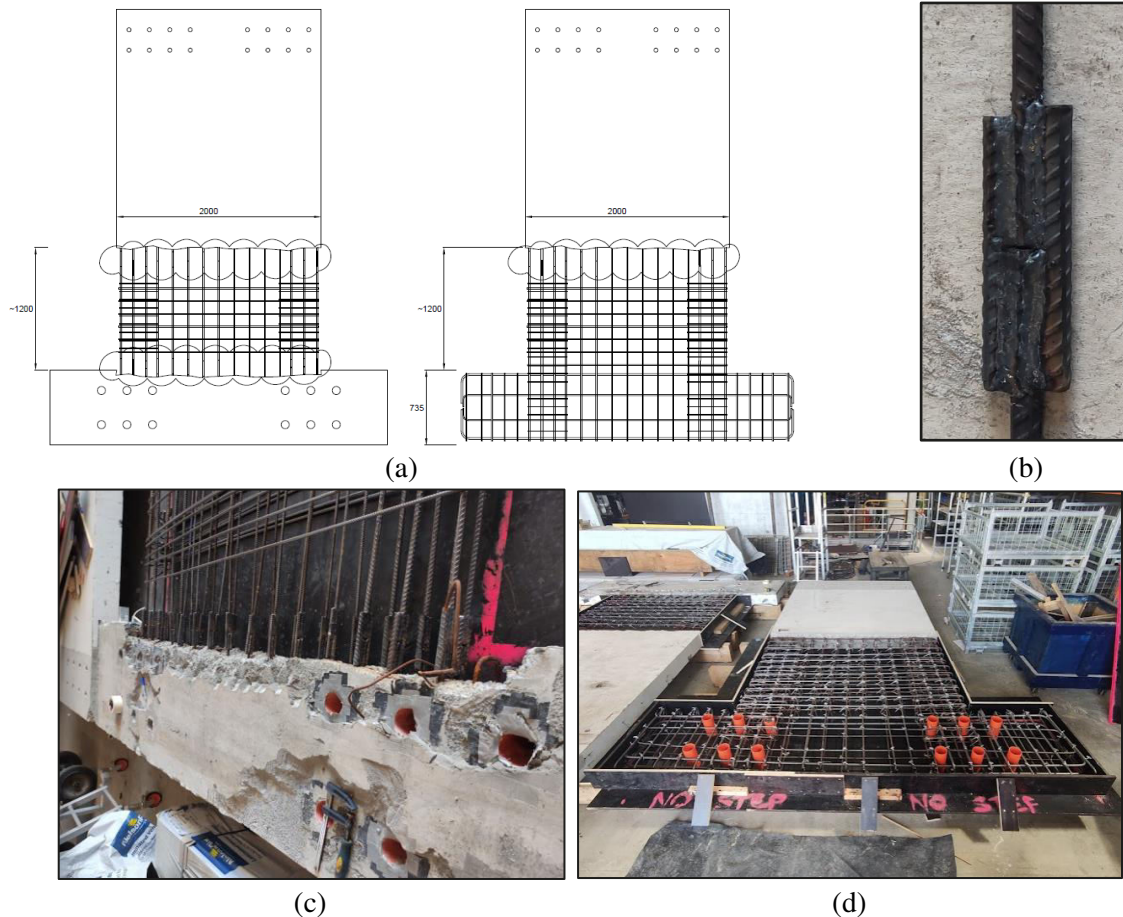
Figure 3: Repair procedure, (a) walls W5D-R and W6C-R, (b) indirect butt welded connection used for the repair, (c) Welded connection at the base of wall W6C-R, and (d) wall W5D-R before pouring the new concrete.

In all cases, the rebars were connected with an indirect butt-welded connection, as shown in Figure 3 (b). The detail of the welded connection meets the requirements of a connection type BI-1d according to the New Zealand Standard of Structural steel welding Part 3: Welding of reinforcing steel, AS/NZS 1554.3:2014 (Standards New Zealand, 2014). New horizontal and transverse reinforcement was provided in the repaired area. Figure 3 (c) shows the discontinuity created by the welded connection at the base of wall W6C-R, and Figure 3 (d) shows wall W5D-R before placing the new concrete.

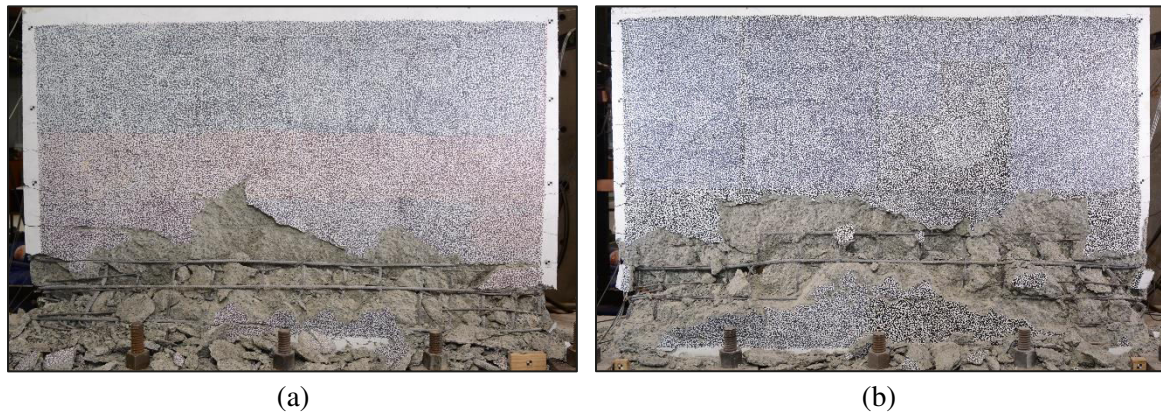
The overall response of repaired walls was similar to that of the benchmark wall W1C. A dominant flexural response combined with a moderate shear crack pattern was observed during the tests. Vertical cracks were observed at the ends of the wall at 0.75% drift, which led to concrete spalling at 1.5% and 2%. The crack pattern was not affected by the presence of the cross-sections with welded connections. Concrete crushing and bar buckling were observed in the boundary element at 2% drift, and the failure of the walls occurred at the second cycle of 3% drift. The damage propagated from the boundary elements towards the centre of the walls, crushing concrete and buckling longitudinal bars. Figure 5 shows walls W5D-R and W6C-R at the end of the test, showing a similar failure between them and compared to walls W1C and W2D (shown in Figure 2). The heavily damaged area in wall W6C-R was slightly above the damaged area in the other three walls. This shift could be explained by the welded connection at the base, which moved the critical section slightly above the original location. However, no significant changes were observed in the overall wall response nor the load-displacement curves, which will be discussed below.

Figure 5: Damage at the end of the tests, (a) wall W5D-R and (b) wall W6C-R.
