Performance of RC buildings in the 2023 Turkey-Syria earthquakes

A.V. Shegay

ABSTRACT

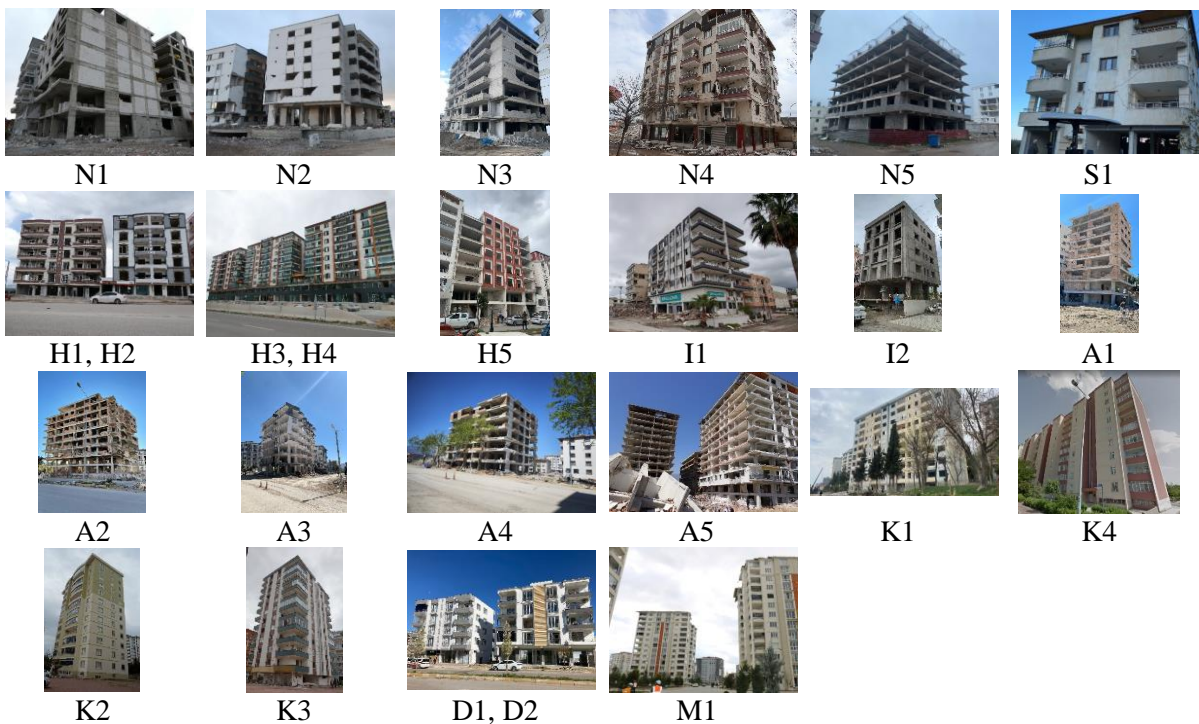
Based on these criteria, data from a total of 25 buildings were collected over several days. The full list of buildings is provided in Table 2, and images for each one is shown in Figure 2. As can be seen from the table, most buildings were new or recently completed (post-2000).

Figure 2: Photos of surveyed buildings.

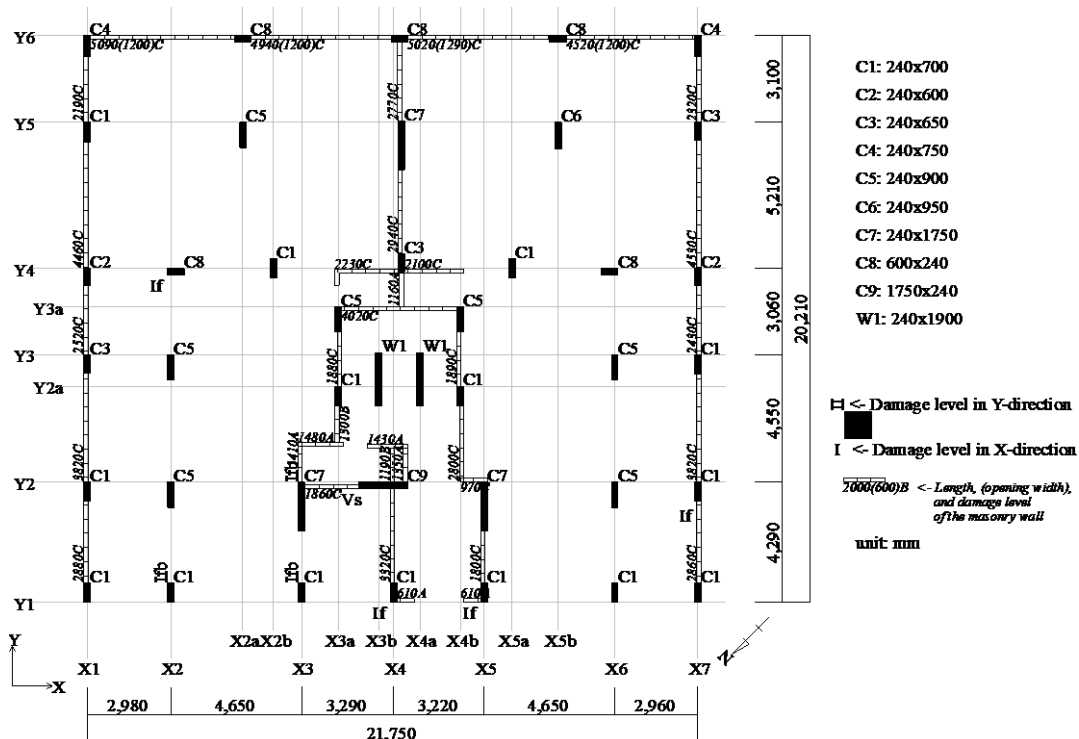
Figure 3: Plan drawing of H1, including damage state of vertical members.

The building has a setback in the elevation direction, with the sections between X1–X2 and X6–X7 being one floor above ground, and the section between X2–X6 being six floors above ground. The elements classified as columns and walls according to the criteria of section 3.3 are labelled as ‘C’ and ‘W’, respectively. The damage levels (in the X and Y directions) of each vertical member columns and walls, judged as level I or higher according to Table 3, are also indicated in the figure (where roman numerals refer to damage level and the ‘f’ and ‘s’ refer to shear or flexure dominant response). The main structural damage observed in this building was the shear failure of column C9 at X4Y2.

Based on these damage levels, an example calculation of the R for the X direction is shown in Table 5. It was determined that the residual capacity ratio in the X-direction was $29.345/31 \times 100 = 94\%$, which corresponds to ‘minor’ damage (JBDPA, 2015). Similarly, in the Y direction, R was determined to be 99%, which corresponds to negligible damage.

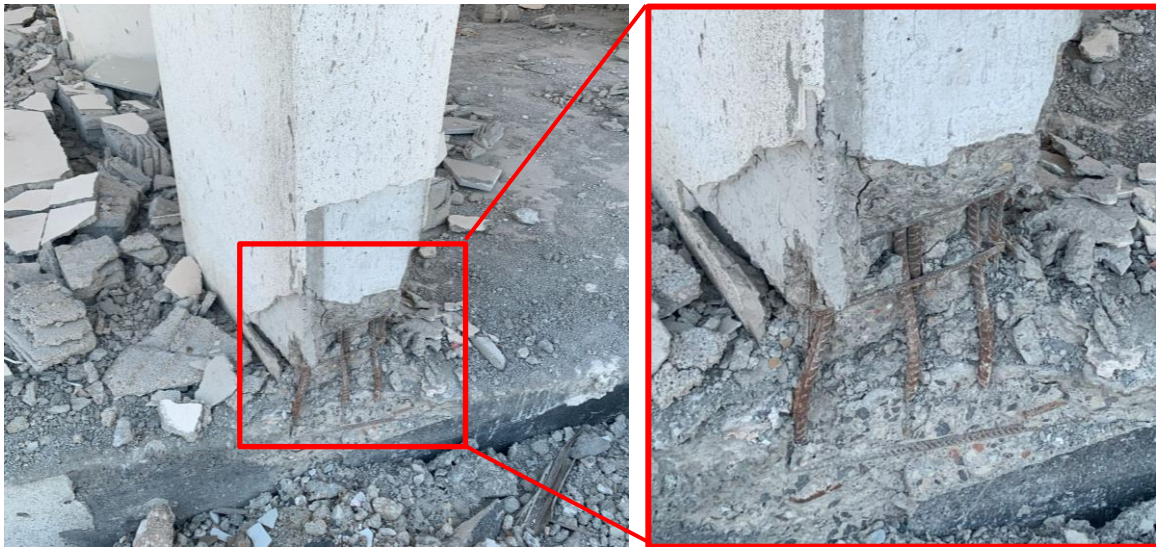
Finally, one of the most common damage patterns observed in the surveyed buildings was the ‘apparent’ buckling of longitudinal reinforcement in the vertical members at the bottom storey. The term ‘apparent’ is used because standard practice in Turkey is to bend starter longitudinal reinforcement rising from the foundation into the member core, as shown in Figure 4. These observations made it difficult to distinguish genuine buckling from intentional formation; thus, damage judgements according to Table 3 may have been overly penalizing in some situations. It is noted that in the most recent version of the Turkish code (TBSC, 2018), splicing in column hinges is required to be installed in the central region of the column (i.e., in region of low moment demands and away from the plastic hinge). In New Zealand, longitudinal reinforcement splices are also not permitted in plastic hinges of columns, so the problem of ‘apparent’ buckling is unlikely

to arise (Standards New Zealand, 2017). This widespread practice of bending rebar in Turkey warrants investigation to determine the effect this has on flexural strength and deformation capacity of plastic hinges.

Figure 4: Intentionally bent longitudinal starter bars appearing as 'buckling'.
