Seismic Resurrection of 13 Storey Apartment Building. 66 Oxford Terrace, Christchurch

R. A Poole

Phoenix Consulting, Christchurch, New Zealand.

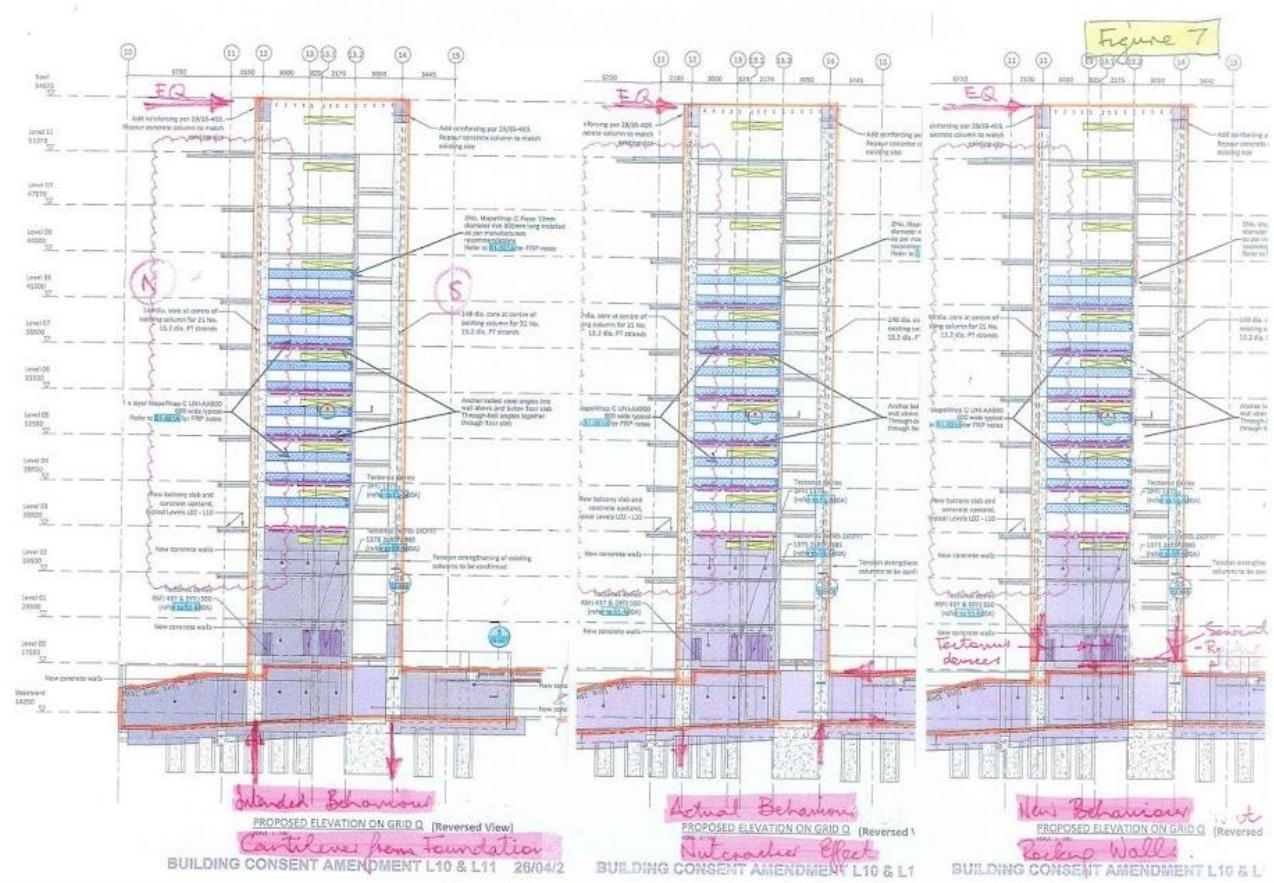
Figure 7

- b. The building was designed on the assumption the shear walls would spring from the basement foundations. However, the building was in fact built into the ground floor, so creating an unintended nutcracker effect. This imposed very heavy shears on the ground floor and caused severe damage. See composite elevations ex S1 - 403 (Figure 7).

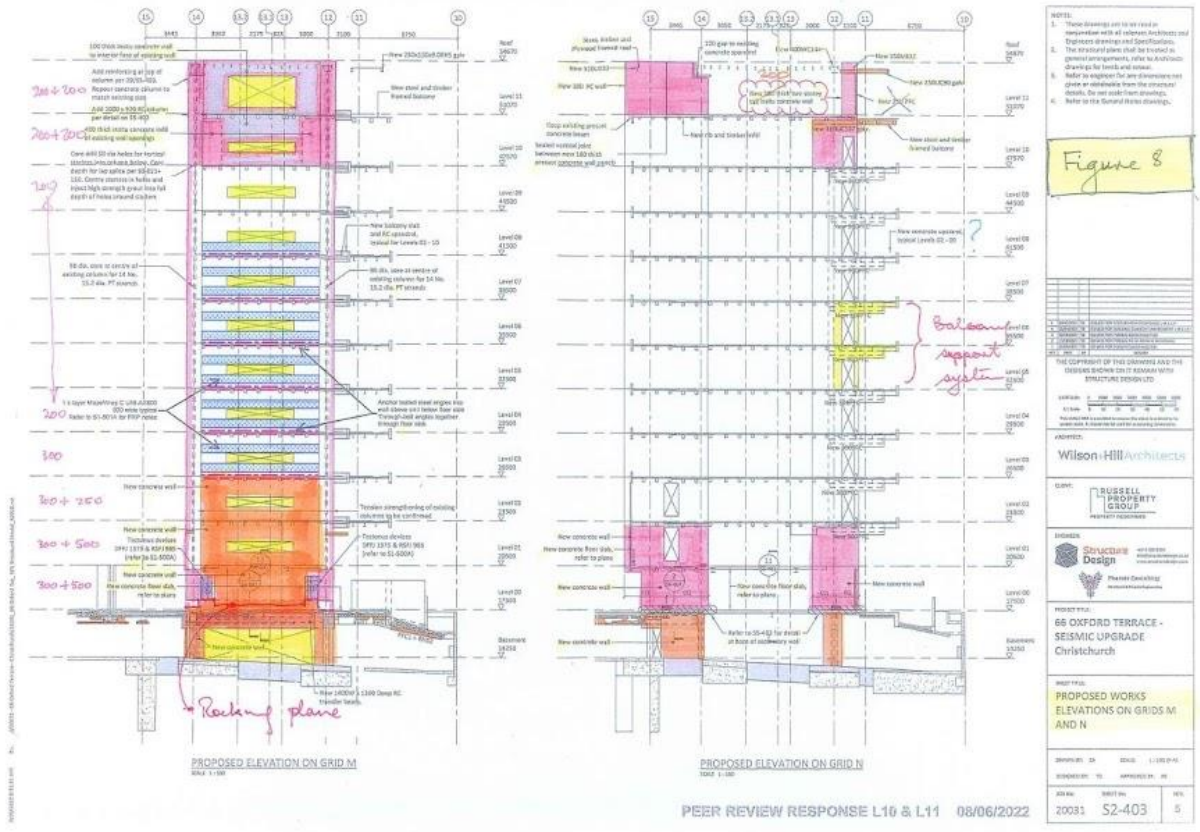
Figure 8

- c. The building has generous east and west walls to resist N/S earthquakes. However because of the long windows they are coupled shear walls but the detailing did not recognise the associated ductility demand. The west wall was omitted in the basement to accommodate car-parking. I believe another structurally sympathetic solution was available. Note drawings S2-403 and S2-405 (Figures 8, 9).

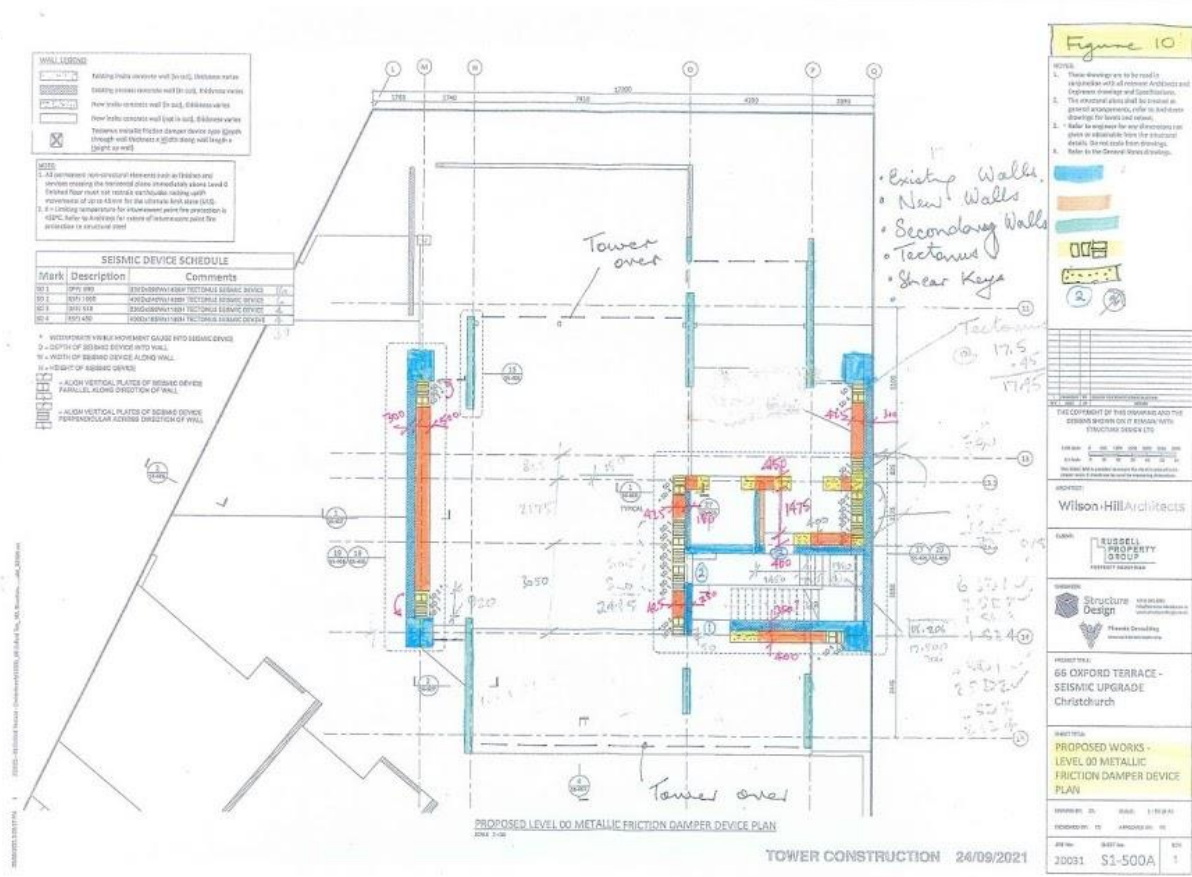
Figure 10

- d. I mentioned earlier the deficiency of the original E/W resisting system of core walls (Figure 10). It did however extend comfortably to a reliable foundation system, essentially a "hockey stick" foundation beam extending across the apartment building (Figure 11).

- e. In the N/S direction there are 6 secondary walls which spring from the ground floor and support the upper floor slabs and in one case most of the load from the substantial balconies (Figure 10). They are generally 180 thick with a single layer of reinforcing. They have no ductile capacity and were vulnerable to compression failure, just like the Pyne Gould Corporation building, which collapsed in the February 2011 earthquake. These walls cannot avoid going along for the seismic ride, but they were not designed to sustain any earthquake loads. The concern is that they could fail in compression or overload the beams they sit on at ground floor level. The February 2011 Earthquake did in fact engender a spectacular shear failure of one beam.
