# QA/QC methods for grouted Drossbach duct connections in precast concrete shear wall panels – case study: new 12-storey building in Auckland

*H. Rowden, V. Patel*

*F. Galvez, R. Hudson & D. Dizhur*

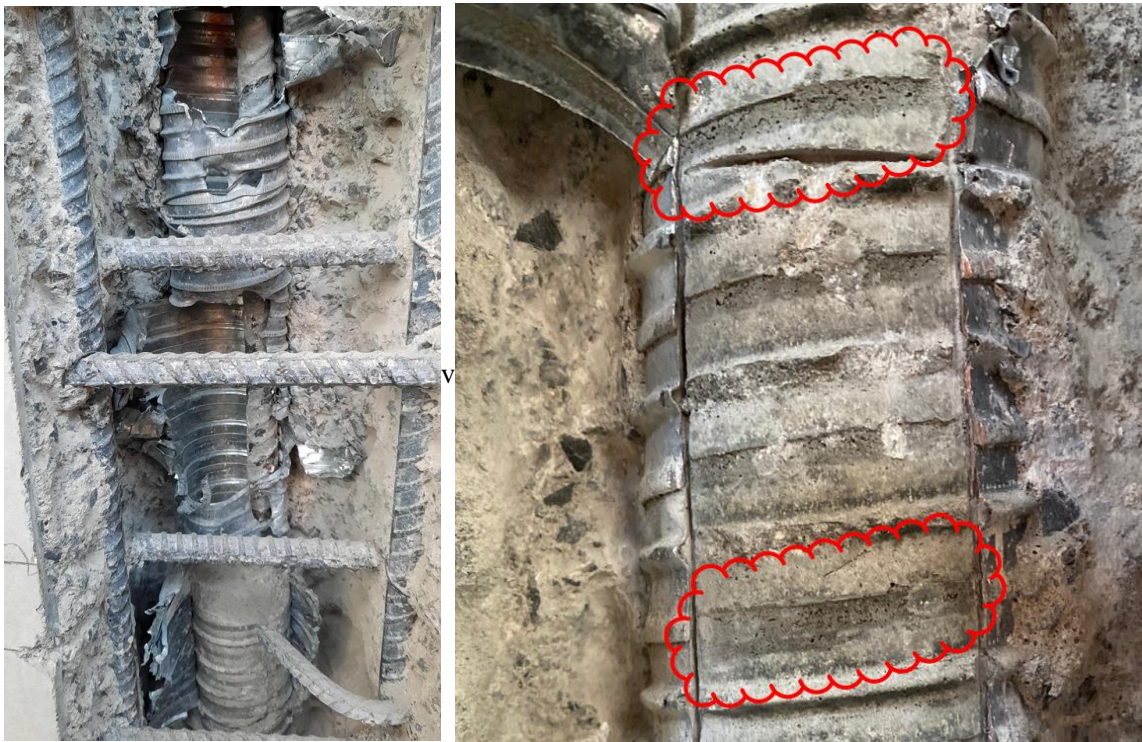
Duct #2 was found to be only partially filled with grout (refer Figure 2 below). Peculiarly, the surface of the starter bar in the exposed Drossbach duct was coated in what appeared to be grout residue, however, this residue was not present on the inside surface of the unfilled portion of the Drossbach duct. It is speculated that this starter bar was likely coated in residue from earlier concrete works, with the site team failing to clean the surface of the bar prior to installing the precast panel above. Following this, a breakdown in the grouting QA processes on site likely resulted in the failure of all grouting stages to be completed for this particular Drossbach duct.

Duct #9 was exposed to reveal what appeared to be pockets of low-density grout (refer Figure 2). Sika NZ Limited (Sika) was contacted for comment on these pockets, to which they responded noting that these micro-bubbles were to be expected for the product being used (SikaGrout-212 NZ), and that these were a by-product of a chemical reaction caused by the shrinkage compensating additives in the grout. Most importantly, Sika noted that the presence of these micro-bubbles would not reduce the material performance of the high strength grout product, and that these micro-bubbles would also have been present in the grout work for the starter bar pull tests conducted earlier in the project.

*Figure 2: Duct #2 exposed showing partial grout filling (left), Duct #9 exposed showing apparent low-density grout / micro-bubbles in red clouded areas (right)*

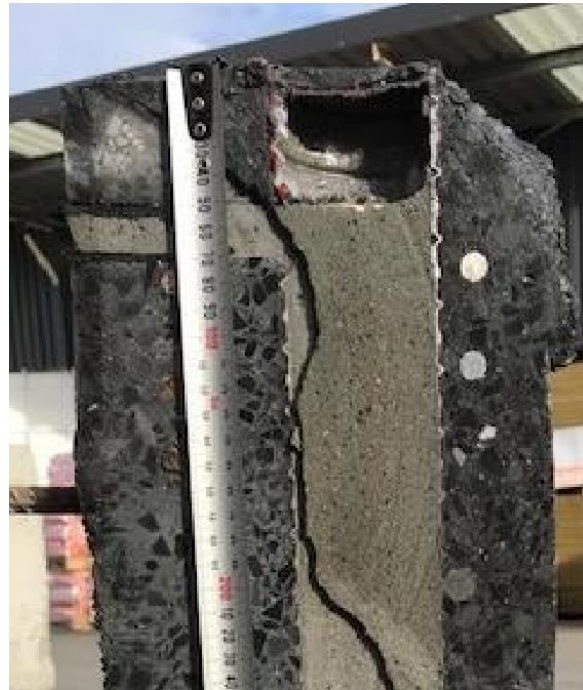
Despite no defects being discovered within the filled portions of the dissected Drossbach ducts, a common air-related defect was found at the very top of several of the ducts (refer Figure 4 below). The sample panels were constructed with the exit grout tubes projecting from the side of the Drossbach ducts, approximately 50mm below the top of the ducts. This meant that the Drossbach ducts were unable to fill right the way up with grout, forming hollow pockets at the top. Whilst this may not seem overly significant due to the starter bars having already terminated and been fully developed at this level, the relatively large diameter of the Drossbach ducts compared to the panel thickness means that a number of these hollow pockets forming side-by-side will reduce the effective cross-section of the panel considerably, creating a plane of inherent weakness.

*Figure 4: Hollow pocket below top of Drossbach duct (note: jagged line in grout caused by panel dissection process)*

Although the initial project detailing having the exit grout tube terminating flush with the top of the Drossbach duct (refer Figure 1) was theoretically sufficient to allow grout to fill right the way up to the top of the duct, failure to adequately fold and seal the entry grout tube after unhooking the grout pump could result in the entry grout tube leaching wet grout, causing the grout level in the duct to slump and form similar hollow pockets. Side-exit grout tubes also have the inherent risk of being inserted incorrectly, resulting in these projecting too deeply into the duct or being obstructed by the starter bar. As such, it was decided to adopt top-exit grout tubes (refer Figure 5 below) for the project's superstructure panels.

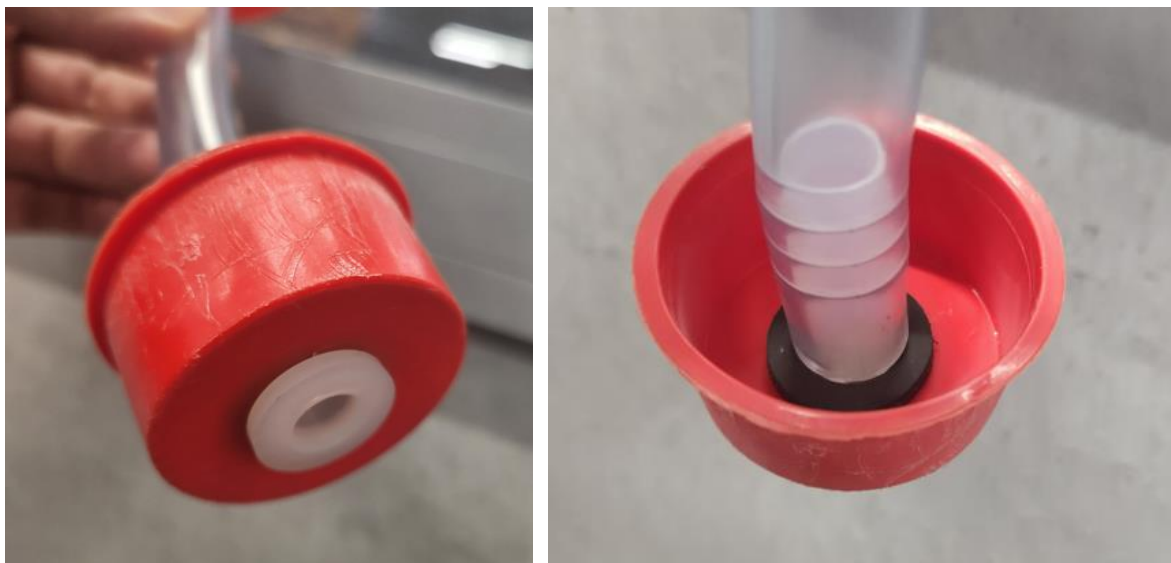
*Figure 5: Underside of top-exit grout tube (left), top side of top-exit grout tube (right)*
