# Establishing the Transverse Load Capacity of a Timber-framed Classroom Block

*D. Brunsdon & M. Willard*

## ABSTRACT

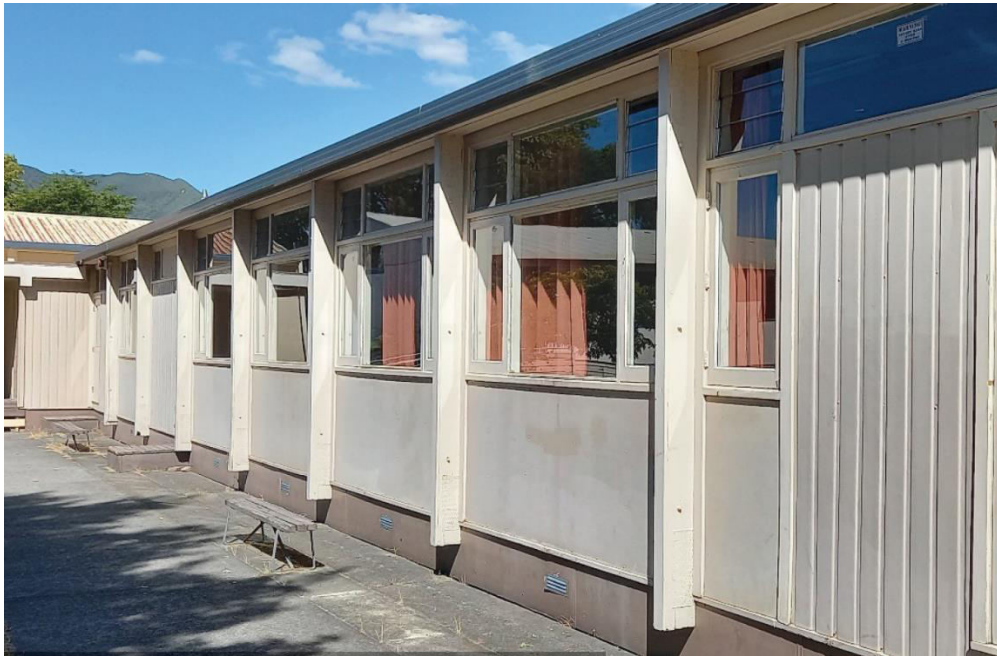
*Figure 1– CEBUS block exterior (note exposed portal columns)*

These portals typically span 7 to 8m depending on the model, and are externally expressed, as indicated in Figure 1. One of the key features of the portals is that they run under the floor to form a continuous frame of the same section size. The end frame is a single 300x50 timber portal from the base module, with the end walls not being designed as bracing walls.

The portal frame elements are joined by externally exposed gang nail plates at apex, knee and floor levels (Figures 1 and 3). The external exposure of the gang nail plates represents a departure from more recent durability practice, and there were signs of delamination and corrosion to several plates in buildings at the school where the testing was undertaken.

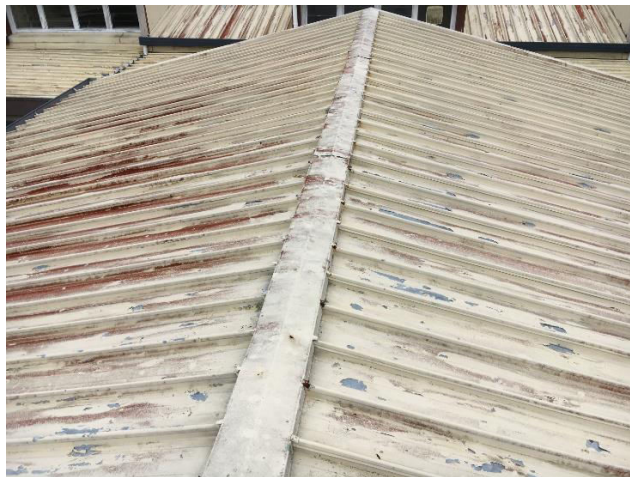
*Figure 2 – CEBUS block roof sheeting*

The roofs are formed from steel sheeting on timber purlins spanning between the portal frames. While the original roof sheeting of CEBUS blocks is corrugated iron, some have been re-roofed in different steel profiles. The roof sheeting of all the blocks at Tauhara College is Brownbuilt with concealed fixings (Figure 2).

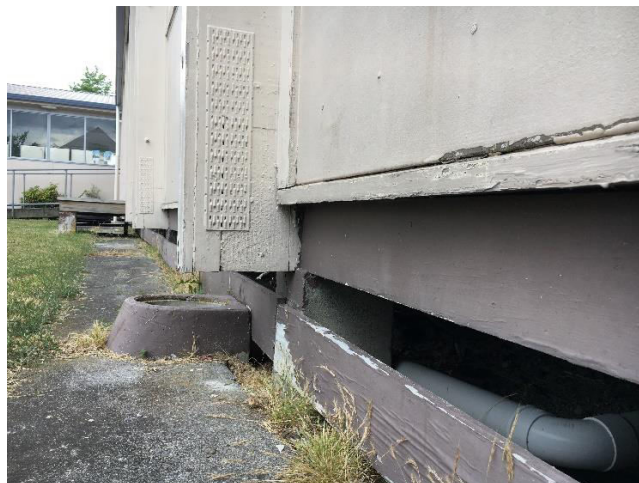
*Figure 3 – Exposed portal base gangnail connections*

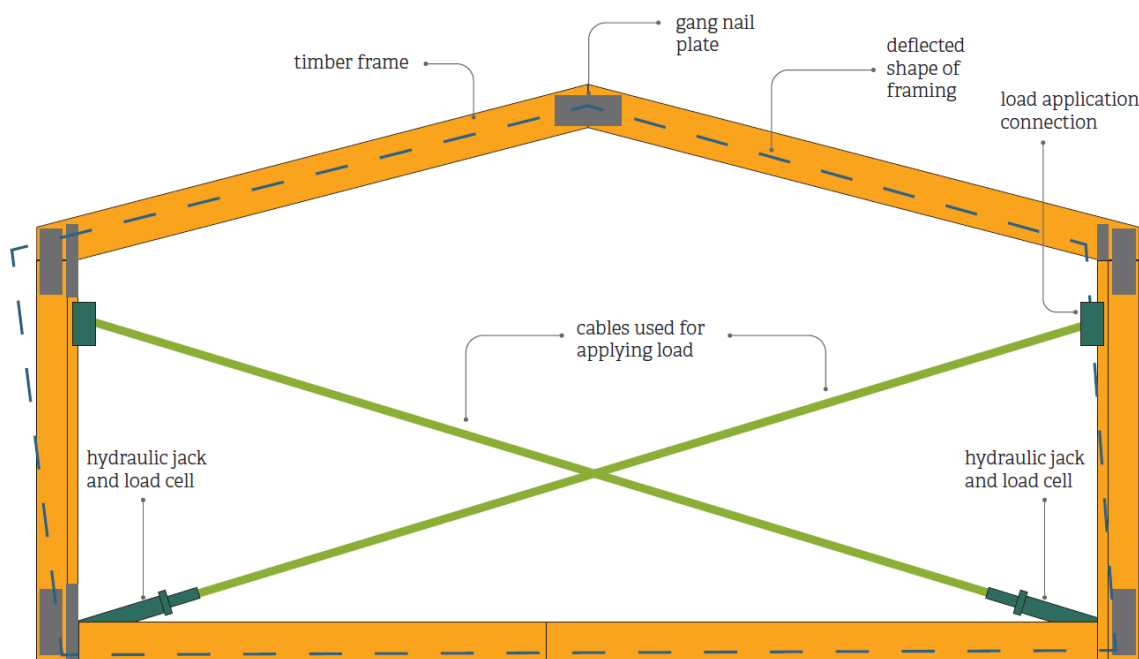
Figure 6 – Schematic loading of portal frame

On-site testing was undertaken using two hydraulic actuators fixed to the floor beams and connected to cables which applied loads near the tops of the columns to simulate earthquake loads from the roof in both directions. Connections to the beams and columns were made with screws through steel plates and threaded rods to avoid adding stiffness to the frames while ensuring minimal slippage of the loading connections (Figure 6). The frames were loaded in each direction to increasing load levels and extensive displacement measurements were recorded throughout testing to quantify the loaded performance of the buildings.

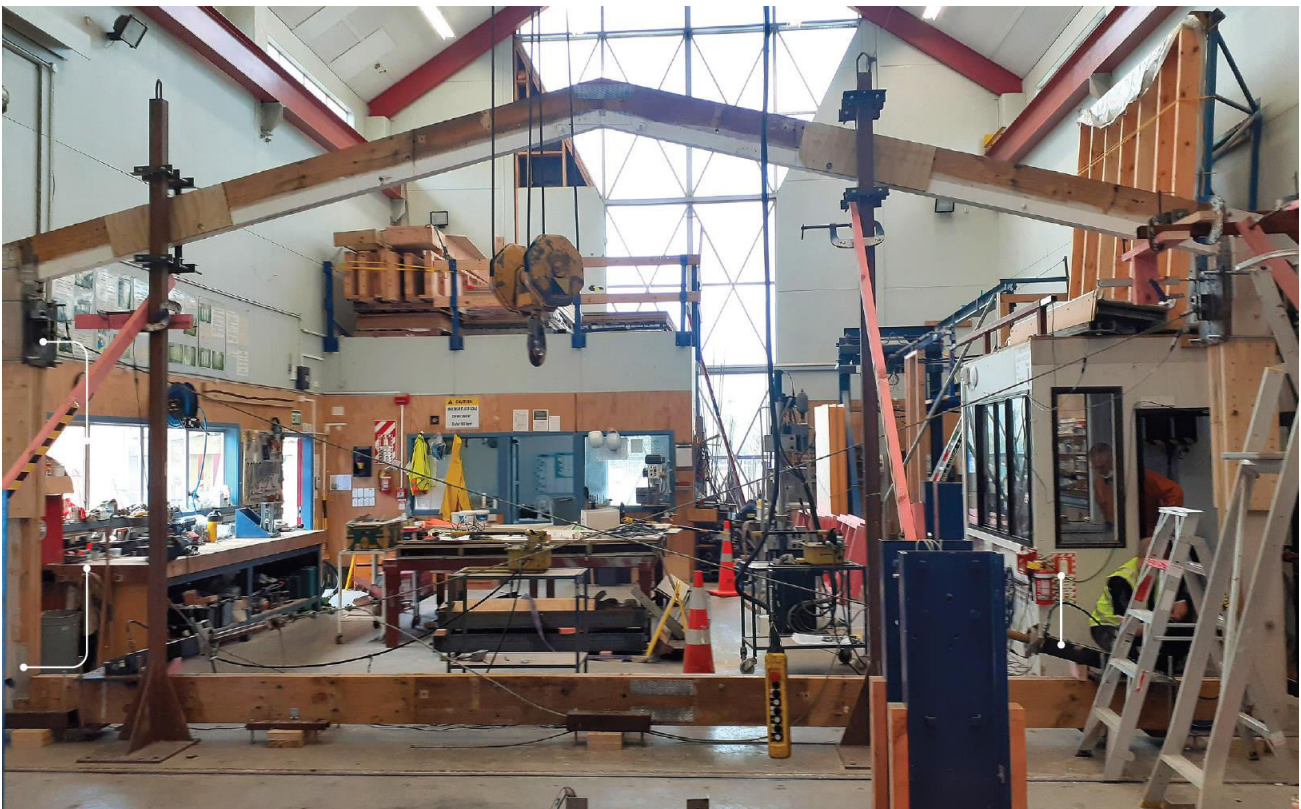
*Figure 7 – BRANZ Structures Lab set up to test CEBUS portal frames*

Following on-site testing, the tested frames were carefully removed from the buildings and transported to the BRANZ Structures Laboratory. It was necessary to cut the columns at mid-height to transport them. Prior to laboratory testing the columns were spliced back together using LVL and screws, which did not compromise the behaviour of the frames during testing. The same loading equipment and attachment locations from the on-site testing were used and both frames were mounted on timber blocks on the laboratory strong floor to simulate the in-situ foundations and also avoid uplift during testing. Rollers were placed on either side of the rafters to model the roof purlins and avoid transverse movements as loads were applied. Displacement measurements were recorded throughout testing and located to allow for comparisons with the on-site testing. The set up of the frame in the laboratory immediately prior to the test is shown in Figure 7.

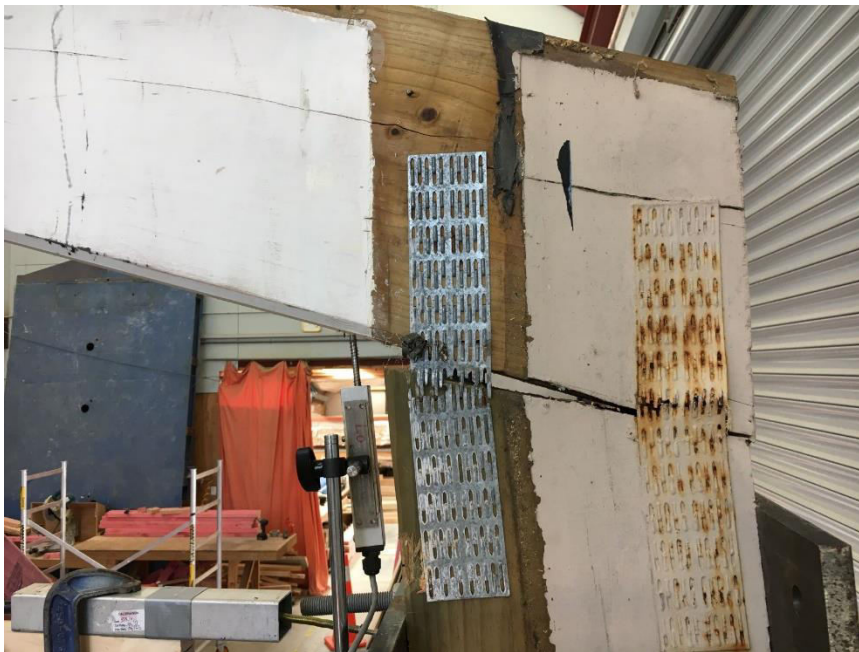
*Figure 8 – Failure of the knee joint of the Block R frame (noting the inadequate anchorage length of the gangnail plates)*

Testing of the Block R frame started with 1kN cycles, but after reaching 2kN in both directions the increment was cut back to 0.5kN due to the greater flexibility of the frame. Horizontal loads of only 5kN were reached before testing was stopped due to large movements, and the frame was considered to have failed. Longitudinal timber splitting of the rafter just beyond the plate connection occurred first at the end of one rafter (Figure 8), followed by buckling and fracture of the gang nail plates at the top of the other column which ended the test. Eave displacements for the Block R frame were approximately 7.5 times those observed in in-situ tests, but at only one-third the load.
