# Impact of base conditions on bracing behaviour of light timber-framed walls

*A. Liu & D. Carradine*

BRANZ, Porirua, New Zealand.

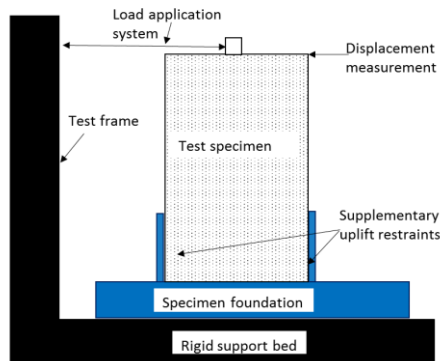
The P21 test is a slow cyclic racking test on a cantilever LTF wall element, and a horizontal load is applied at the top of the wall as a series of three displacement-controlled cycles to displacements of  $\pm 9$ ,  $\pm 15$ ,  $\pm 22$ ,  $\pm 29$ ,  $\pm 36$  and  $\pm 43$  mm. The test arrangement and the load protocol for a typical P21 test are respectively illustrated in Figure 2 and Figure 3.

Figure 2: P21 test arrangement

The P21 test procedure only requires that the applied load and the in-plane deflection be measured at the top of the specimen. The lateral displacement measured at the top of the specimen is the sum of all contributions from different deformation mechanisms including uplift at the wall base, screw slip and elastic deformation within the sheathing as well as the deformation of the frames.

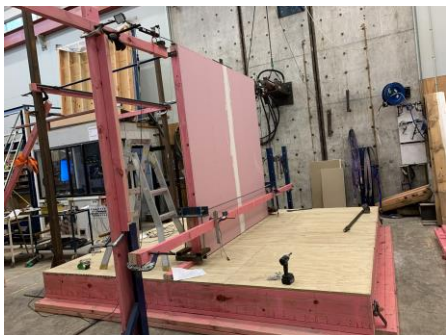
The testing was carried out in the BRANZ structures laboratory and the test setup is shown in Figure 5. The test was conducted using a displacement-based quasi-static fully reversed cyclic loading protocol. For all the tests, the actuator displacement cycles continued well over  $\pm 60$  mm, which was well beyond the conventional displacement range of P21 tests. All the testing was terminated due to significant floor damage and reduction of the applied loads.

Figure 5. Test setup of LTF walls on suspended timber floors

The test specimen was extensively instrumented using displacement potentiometers and load cells. These instruments were arranged to quantify the behaviour of different parts of the system. In detail, linear potentiometers were used to record the horizontal displacements at the wall top plate relative to the strong floor within the wall plane, the vertical displacements of the wall end studs relative to the floor, the vertical displacements of the floor at the wall end stud locations relative to the strong floor (as illustrated in Figure 5). Applied loads and actuator's displacements were also recorded using the built-in instrumentations.

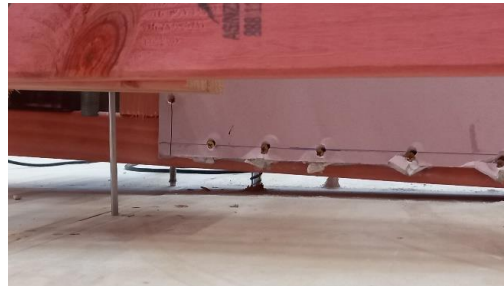
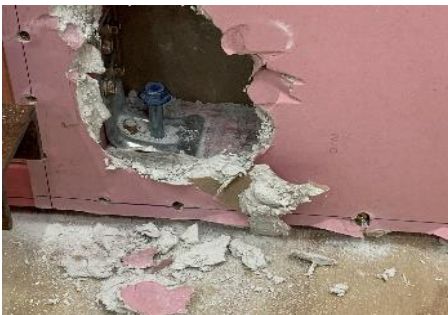
The 1.2 m long wall parallel to the joist orientation was the first test conducted in this test program. During the early loading cycles of the test, no visible damage was observed in any parts of the test specimen until the loading cycle of 36 mm when some screw distressing appeared close to the wall base. The attained load was peaked at the loading cycle of 43 mm and the peak strength attained was 8.3 kN. As the test progressed to the loading cycle of 50 mm, screw detachment and wall lift-up were observed. In addition, loud noise was heard from the timber crushing within the floor. At the loading cycles of 65 mm, more timber crushing was heard and Handibrac bolts were pulled out from the floor. The attained load dropped significantly and the test was terminated at the loading cycle of 75 mm where the attained load dropped to 2.0 kN. Figure 6 shows the damage progression and the exposed view of Handibrac at the completion of the test.

(a) Screw detachment initiated

(b) Handibrac pulled out of the floor

(c) Exposed view of Handibrac screw pulled out

Figure 6. Damage development and the exposed view of Handibrac (1.2 m wall parallel to joist orientation)

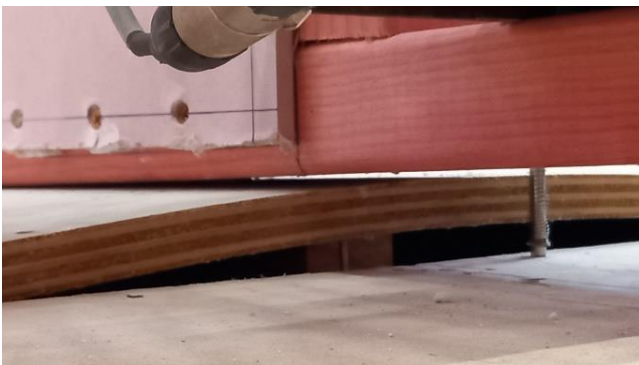
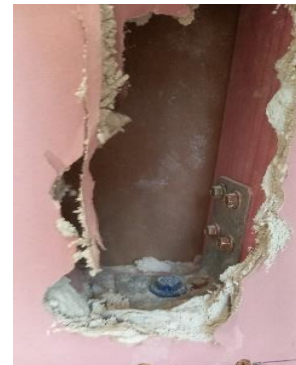
As the test progressed, the attained loading continued to increase and the damage progression is limited to the floor lift-up development only. The peak strength was reached at the loading cycles of 57 mm. A piece of the 19 mm flooring close to Handibrac was significantly lifted up at the loading cycle of 75 mm and the attained loading started to drop. The attained peak strength was 8.3 kN. Subsequent loading cycles caused some screw damage from plasterboard to timber framing at one wall end and the test was terminated at the loading cycle of 95 mm due to significant load drop. Figure 7 shows the flooring lift up and the exposed view of Handibrac bolt connection after the completion of the test.

(a) Floor damage

(b) exposed view of Handibrac hold-down device

Figure 7. Floor damage and the exposed view of Handibrac (1.2 m perpendicular to joist orientation)

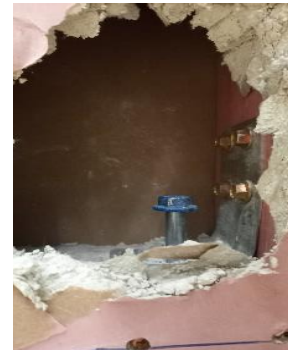
As the loading continued, the noise continued and the Handibrac bolt started to be pulled out at the up-lifting end of the wall during the loading cycles of 36 mm. The bolt pull-out continued and screw distressing around the wall ends at the wall base was also observed as the loading continued. The sustained load started to drop at the loading cycles of 50 mm. Subsequent loading caused more significant bolt pull-out as well as screw detachments around the wall ends at the wall base. The test was terminated at the completion of the loading cycles of 65 mm. Figure 8 shows the revealed the Handibrac connection after the completion of the test.

*(a) Wall up-lifting (Handibrac bolt pull-out)*

*(b) exposed view of Handibrac hold-down device*

*Figure 8. Uplift of the wall and the exposed view of Handibrac (2.4 m parallel to Joist orientation)*

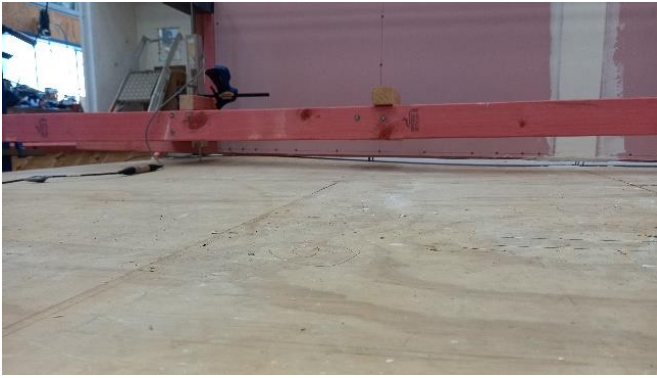
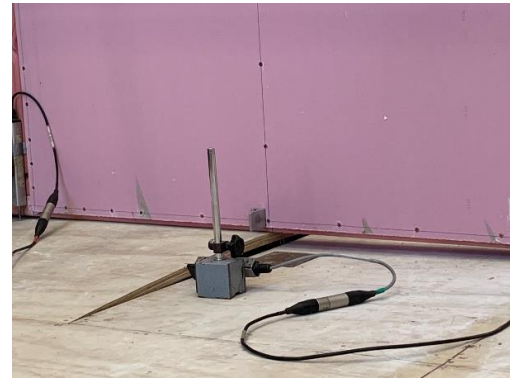
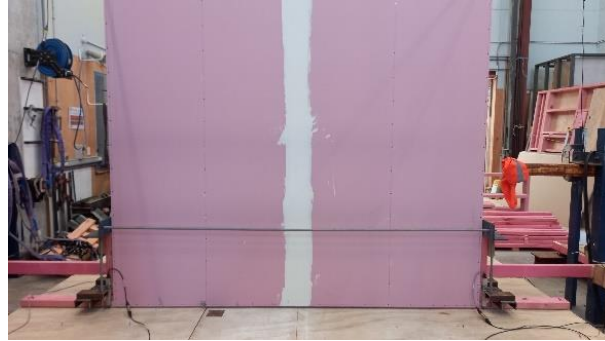
As the loading cycles continued, the noise of timber crushing continued. However no apparent damage to the wall was observed and the attained load continued to increase. During the loading cycles of 36 mm, the floor displayed apparent out-of-plane bowing and the attained load was peaked. When the loading progressed to cycles of 50 mm, significant flooring lift-up initiated and the attained load started to drop slightly. Subsequent loading cycles caused more significant flooring lift-up but the wall remained unscathed. The test was terminated at the completion of the loading cycles of 65 mm. Figure 9 shows the various damage and the final appearance of the 2.4 m long wall perpendicular to joint orientation.

(a) Out-of-plane bowing of the floor

(b) Flooring lift up along the flooring joint

(c) Final appearance of the 2.4 m wall on suspended timber floor (perpendicular to joist orientation)

Figure 9. Deformation and damage of the floor, the exposed view of Handibrac (2.4 m wall perpendicular to joist orientation)

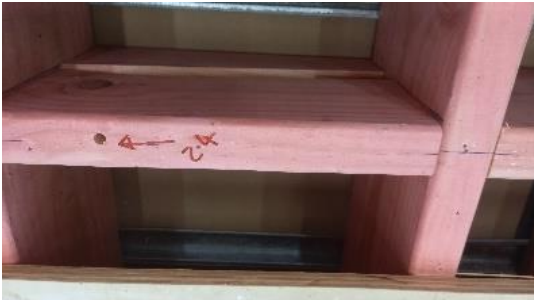
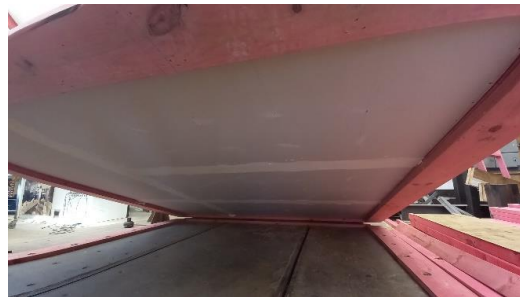
After the four wall tests were completed, the floor framing was exposed to see the damage within the floor framing. Figure 10 shows the damage to the floor framing, including the splitting of the blocking under the walls perpendicular to the joint orientation, the vertical movements of the blockings. The ceiling has maintained its integrity and had no damage at all.

(a) Splitting of the blocking framing

(b) Out-of-plane movement of the floor timber

(c). Final appearance of the ceiling

Figure 10. Summary of damage within the floor at the completion of all the four tests

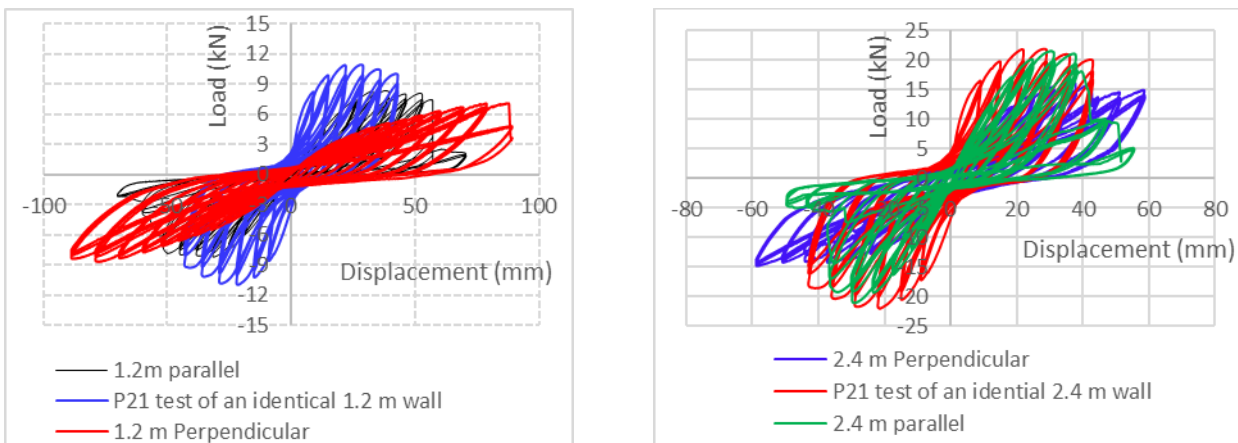
(a). the 1.2 m long walls

(b). the 2.4 m long walls

Figure 12. Comparison of the hysteresis behaviour of 1.2 m and 2.4 m long walls on suspended timber floor

Analysis of the test data showed that the attained strength and stiffness of the walls on suspended timber floors, at a specific displacement level, are significantly lower than the correspondent strength and stiffness obtained from similar P21 tests. For instance, the attained bracing strengths and stiffness for 1.2 m walls were only about 21% to 35%, 31% to 56%, 38% to 70%, 46% to 80% of the correspondent values obtained from P21 tests at the displacement of around 9 mm, 22 mm, 30 mm and 36 mm respectively. Clearly the rated bracing capacity by P21 tests is significantly higher than the measured bracing capacity of the walls on suspended timber floors undertaken in this study.

- P21 test procedure is likely to overestimate the strength and stiffness performance of LTF walls on suspended timber floors. The discrepancy is greater for shorter walls in comparison with longer walls and the discrepancy is greater for the walls oriented perpendicular to the joist orientation in comparison with the walls orientated parallel to joist orientation.
- LTF walls on suspended timber floors, when orientated along the joist orientation, are likely to have higher bracing strengths and higher stiffness than the counterparts oriented perpendicular to the joist orientation.
