Pres-Lam: An innovative and collaborative timber solution.

Paper 98 – Pres-Lam: An innovative and collaborative timber solution.

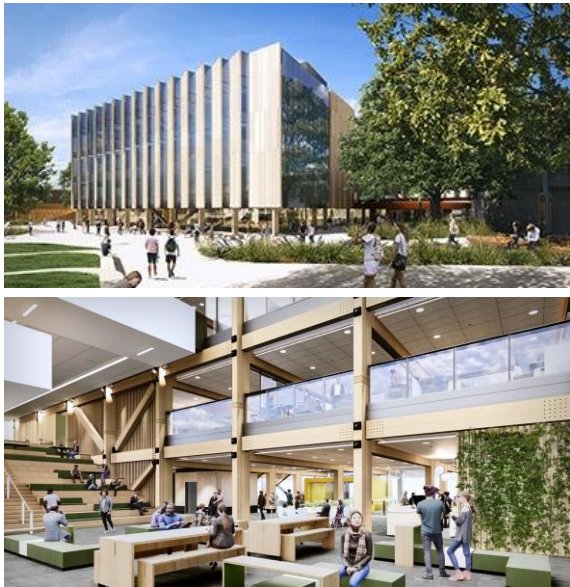
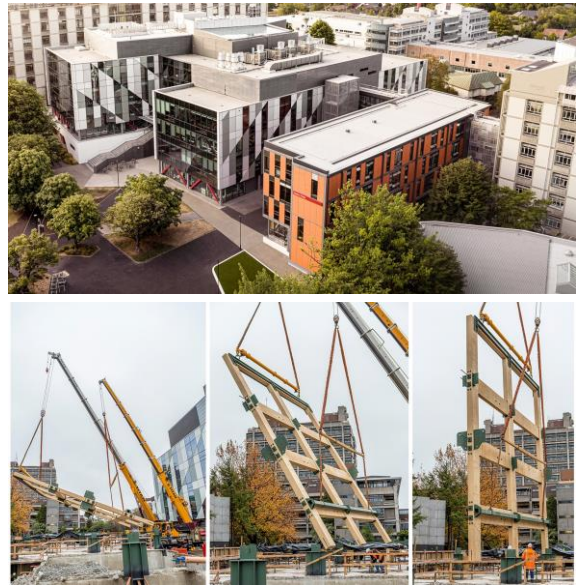
Figure 1: Pres-Lam rocking frame projects. Image credits: Jasmax, Beca

AUT A1 – Auckland University (2020-2024)

Beatrice Tinsley – Canterbury University (2016-2019)

AUT A1 at Auckland University of Technology which implements a series of Pres-Lam moment resisting frames (MRF) (Smith 2014). The MRF consists of large structural members made of LVL, used for the greater size, stiffness and strength properties when compared with sawn timber. The LVL frame also offers a relatively lightweight structural form which reduces overall building loads on the foundation as well as the seismic system. This system is similar to that implemented in the Beatrice Tinsley building at Canterbury University (Kirstein 2018).

The post-tensioning in AUT A1 consists of two unbonded Macalloy Bar at each level, extending the full width of the building. The post-tensioned connection between beam and column allows for seismic movement to be accommodated through 'controlled rocking', reducing the overall seismic loads on the building. The connection capacity can be tuned so that the structure behaves in a preferred manner – in this

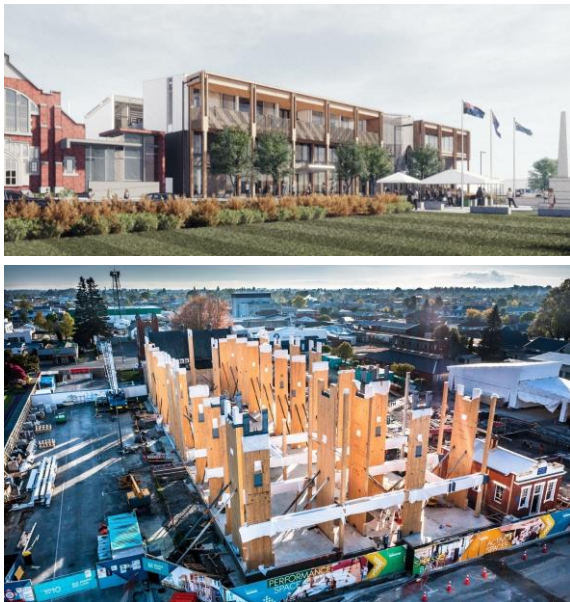
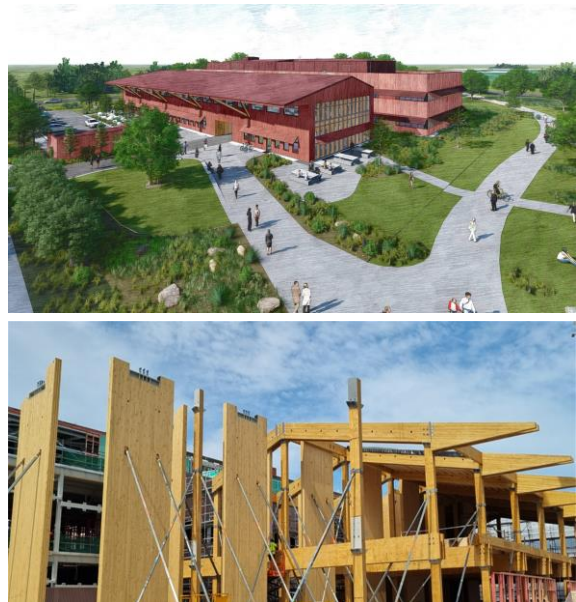
Figure 2: Pres-Lam rocking walls projects. Image credits: Athfield Architects, Architectus, Beca

Ashburton Civic Centre – Ashburton (2020-2024)

AgResearch – Lincoln (2021-2023)

Two projects which have implemented Pres-Lam rocking walls: the Ashburton Library and Civic Centre and the AgResearch building. Both projects implemented CLT as the timber wall material for its strength and stiffness in both vertical and horizontal directions and high strength Macalloy steel bars for the post tensioning. Design constraints for the post tensioning are the same as if these were more traditional concrete walls but with greatly reduced building loads.

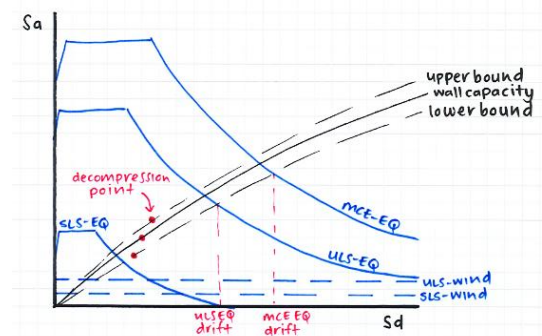
Figure 4: Example pushover plot of a wall

Beca used a bounded approach to ensure the walls would meet the four criteria above both the day it is tensioned (when post tensioning forces will be highest) and after the 50-year design life when timber creep and bar relaxation will have reduced the post tensioning force. An additional margin was added to account for some inaccuracy due to limitations in the post tensioning equipment and procedures. Figure 4 shows an example of a pushover for a specified post tensioning level.
