Structural engineering observations from the 26 November 2019 M_w 6.4 Albanian earthquake

A.W. Charleson

ABSTRACT

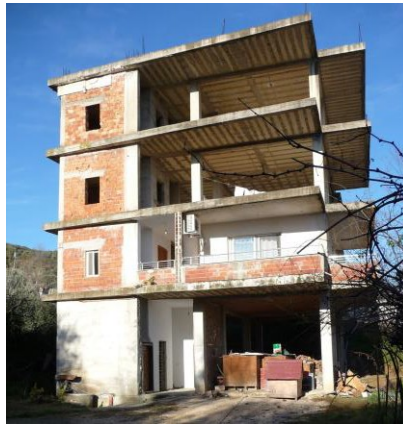
The most common method of construction, at least around Durres, is reinforced concrete frames and infill walls. Popular since the 1980s to the present time, this construction typology is used for single- and double-storey detached houses through to apartments 12 storeys high. In these frame and infill buildings the frames and the entire concrete skeletons are constructed first and then infilled with hollow clay bricks which are then plastered (Figure 4). Interior walls are of the same material and construction type.

Figure 4: A reinforced concrete frame is completed and then walls are infilled

According to local code requirements, a mid-height horizontal reinforced concrete band is required in each infill to resist face-loads, but this member was not seen in any damaged building. Since the infills and partitions are constructed after the completion of the concrete frame the only connection between infill and frame members is mortar. Walls are therefore very vulnerable to out-of-plane collapse and this was a very frequent occurrence. This lack of reliable connection between infill and frame contrasts distinctly with Confined Masonry construction. In this technique, masonry walls are constructed first, and only then are reinforced concrete tie-columns and beams cast. This construction sequence ensures the masonry is confined and therefore can resist lateral loads more reliably than infilled frames (Meli and Brzev 2011).

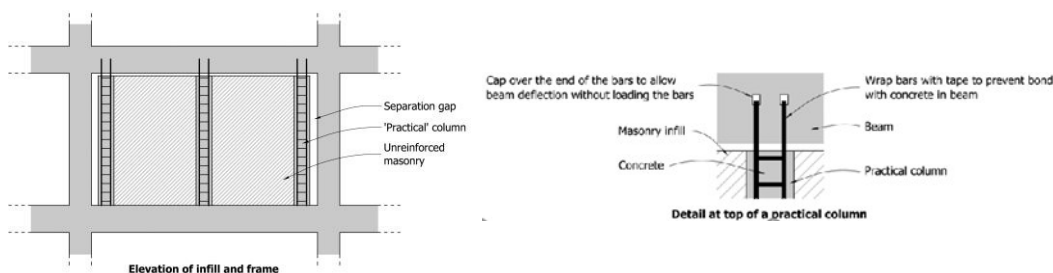
Figure 11: Suggested masonry infill separation detail

Avoidance is the most common strategy to overcome the problems identified above. Light-weight and relatively flexible infills are one option, followed by precast panels whose flexible connections to frames are detailed to accommodate calculated interstorey drifts. Another solution involves designing the primary structural system stiff enough to protect unseparated infills. Otherwise, if masonry infills are to be used the best strategy is to separate. A recommended detail is shown in Figure 11 (Hollings 1981).

This detail prevents the infill forming a diagonal compression strut and experiencing diagonal tension. The vertical ‘practical’ columns, essentially vertical beams, support the infill against face loads. For more information refer to Charleson (2008) who devotes an entire chapter to this topic. However, the solution of Figure 11 is not ideal. The presence of the infill stiffens and strengthens the beam, and prevents normal length plastic hinges forming at beam ends during an earthquake. Instead of distributed cracking along beams up to twice their depths, one wide crack will form at column faces, greatly limiting the ductility capacity of the hinges. Debonding beam longitudinal steel in the potential plastic hinge region may be worth investigating to improve inelastic performance.
