Seismic retrofit of historic timber structures: Uncertainties and adaption on site

M. E. Davies, G. W. Alley & A. G. Cattanach

Dunning Thornton Consultants Ltd, Wellington.

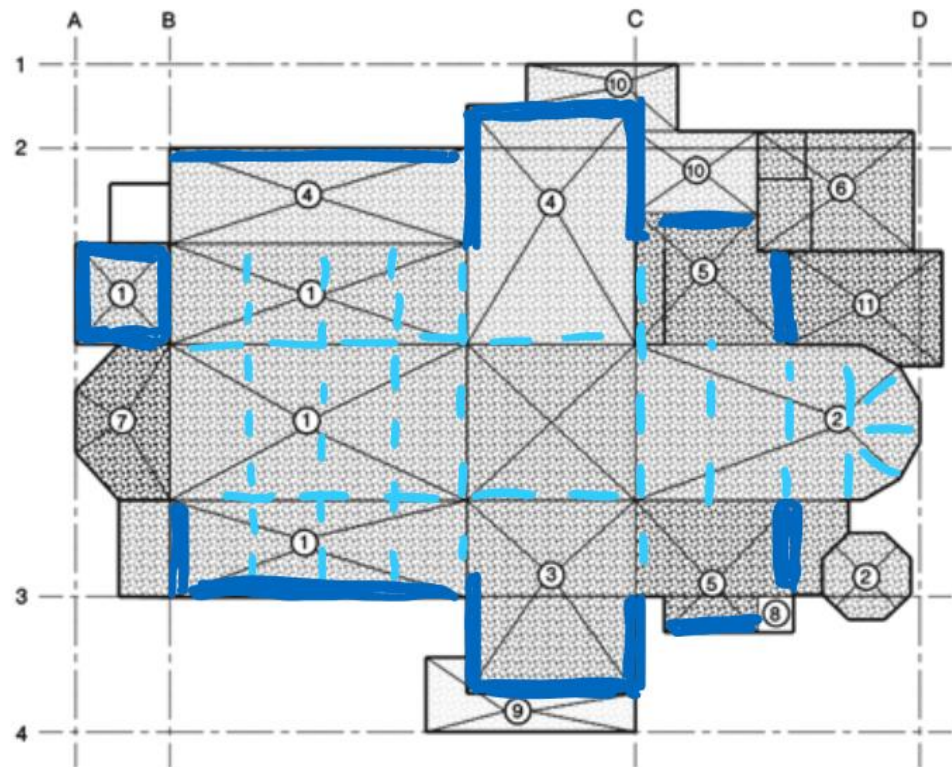
As noted in the previous section, and described in Figure 3, the building is generally very flexible in the central areas (the nave, aisles, crossing, and apse). The walls in the north and south transepts and bell tower had historically been retrofit with diagonal timber bracing to reduce sway in the wind. This meant there were parts of the building with higher stiffness, excepting that the connections of the diagonal bracing typically had negligible tension capacity.

Figure 3: Schematic of lateral load resistance mechanism

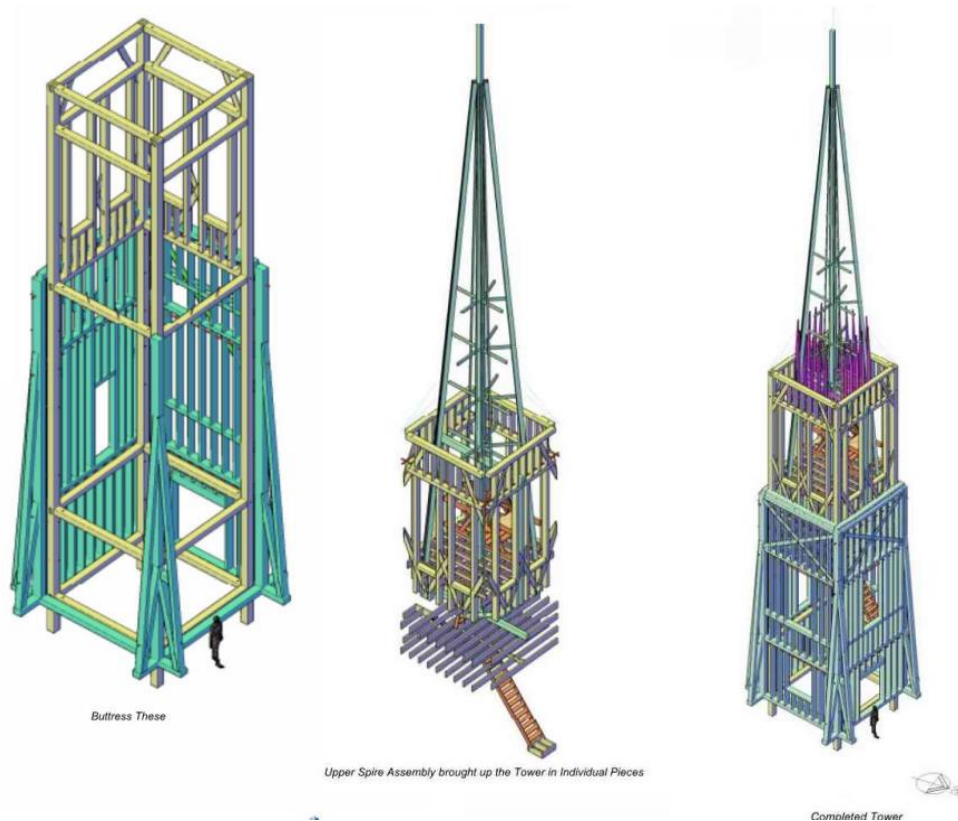
Figure 6: Drafting assumed construction sequence to understand layers of framing in the towers.

Following Wellington City Council's seismic assessment programme in the late 2000's, Dunning Thornton carried out a Detailed Seismic Assessment in 2012 using the (brief) timber guidance in the 2006 guidelines. Our work was based on some detailed plans prepared by Chris Cochran heritage architect, plus non-intrusive measure-up and investigations in the bell towers, roof space, and subfloor. Investigative and deductive work by Senior Draftsman Martin Williams made sense of what appeared to be double-frames in the towers by simulating the way it could have been built and buttressed (Fig. 6) in stages, given the equipment available in the 1880's.
