Testing of heavily damaged reinforced concrete walls repaired using concrete and steel replacement

G. Muñoz, R. Henry & K. Elwood

University of Auckland, Auckland, New Zealand.

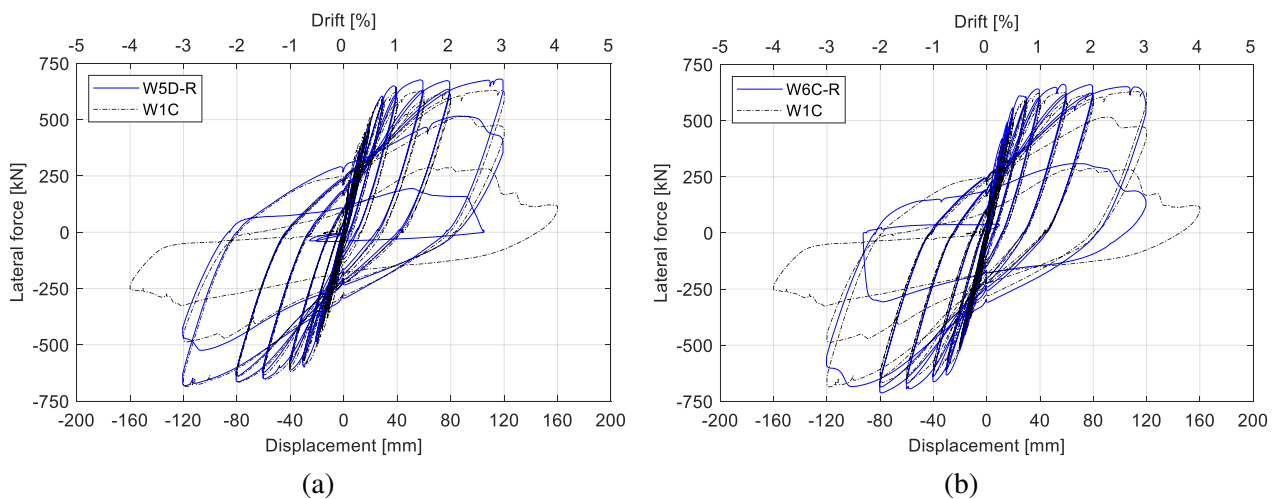
Figure 6: Load displacement responses, (a) wall W5D-R, and (b) wall W6C-R.

Figure 6 shows the lateral load-displacement responses of the repaired walls compared to the response of the benchmark wall W1C. As observed from the figure, the wall responses are similar to wall W1C, showing a stable behaviour of up to 3% lateral drift. Wall W6C-R had a slight drop in strength at the end of the first cycle at 3% drift, but the response was still almost identical to W1C. The fact that the severe damage was shifted above the section of the other walls can explain the negligible reduction in the displacement capacity. The fact that wall W1C sustained cycles to 4% is not considered relevant considering the significant reduction in lateral strength on those cycles. Different sources can explain the increment in the strength of the repaired walls. In wall W5D-R, the increment occurred only in the positive direction, indicating that the difference may have occurred by slight offsets in the reinforcement or the test setup. The symmetrical increment observed in wall W6C-R may be explained by the shift of the critical section closer to the top of the wall. A reduction in the effective height will increase the wall lateral strength to achieve the same moment capacity. However, the range of these differences is small and should not be critical in analysing the repaired walls' response.

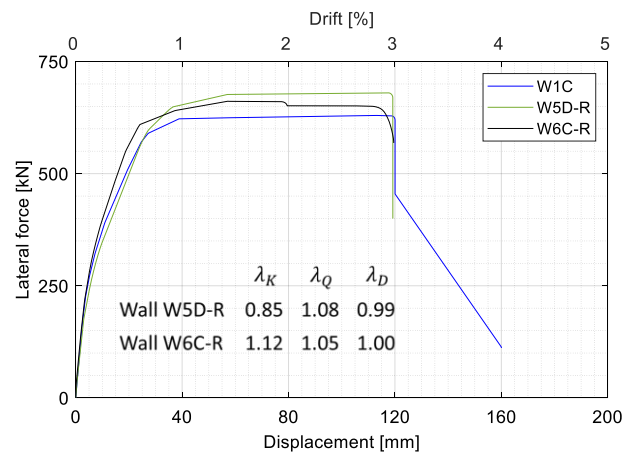
Figure 7: Backbone curves and performance modification factors.

To better understand the repaired walls' seismic performance, backbone curves were extracted from the load-displacement responses and are plotted in Figure 7. Immediately it can be observed that the curves are similar to W1C. The figure also shows values of performance modification factor, similar to the ones defined by FEMA 306, Evaluation of earthquake damaged concrete and masonry wall buildings (ATC, 1998).

Stiffness, strength, and displacement capacity are defined for each curve, and then the ratio of repaired over original is the performance modification factor, λ . Stiffness, K , is defined as the secant stiffness obtained at 70% of the wall strength. Strength, Q , is defined as the maximum lateral force resisted by the walls. Displacement capacity, D , is defined as the displacement value at a 20% drop in lateral force. Values shown in Figure 8 indicate a successful repair procedure for both walls. In terms of stiffness, the range of $\pm 15\%$ variation does not significantly impact the building behaviour under seismic conditions. Both repaired walls had a minor overstrength, which was also considered negligible to the wall response. A capacity design recheck could be done to ensure that sufficient shear strength is maintained. The most important outcome is the essentially identical displacement capacity. These results show that a complex repair procedure replacing concrete and reinforcing steel can achieve a similar response compared to the original wall when adequately conducted.
