Seismic Resurrection of 13 Storey Apartment Building. 66 Oxford Terrace, Christchurch

R. A Poole

Phoenix Consulting, Christchurch, New Zealand.

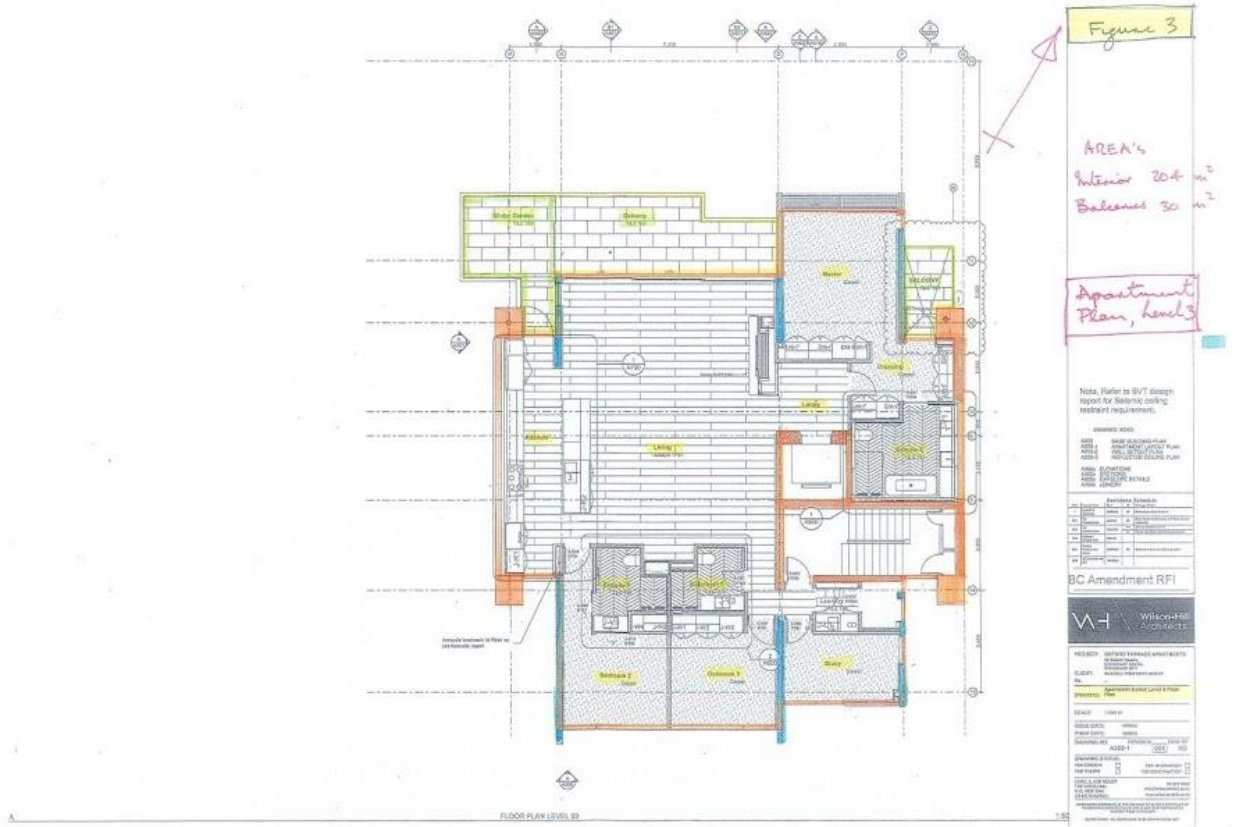
Figure 3

The next drawing is an architectural floor plan of a typical floor. (Figure 3). Note there is a generous central kitchen/ living space; there are three bedrooms with en-suite bathrooms, a study and a small laundry. To cap it off is the 30m² balcony. A master stroke in the resurrection was the decision to glass off the west end of the balcony as a Winter Garden, which also improves the utility of the balcony. Looking at the plan, I do wonder how architectural minds work? No doubt the building is more interesting as a visual feature in the city scape, but I wonder about the complexity of the plan. There are 24 separate exterior wall surfaces. An engineer would have adopted a much simpler "squarish" plan which would have made the design and construction much easier.

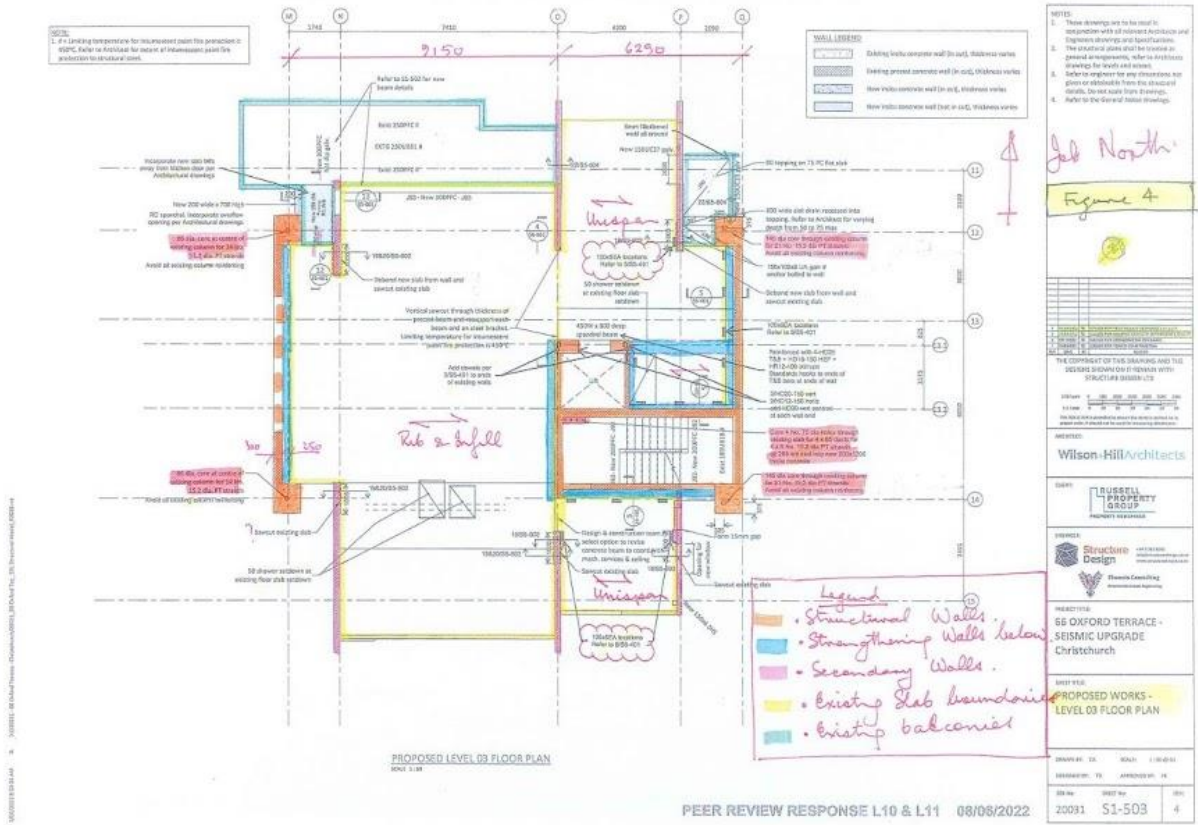
Figure 4

I now refer to the structure of the tower and drawing S1-503 (Figure 4) and note the following:
