# QA/QC methods for grouted Drossbach duct connections in precast concrete shear wall panels – case study: new 12-storey building in Auckland

*H. Rowden, V. Patel*

*F. Galvez, R. Hudson & D. Dizhur*

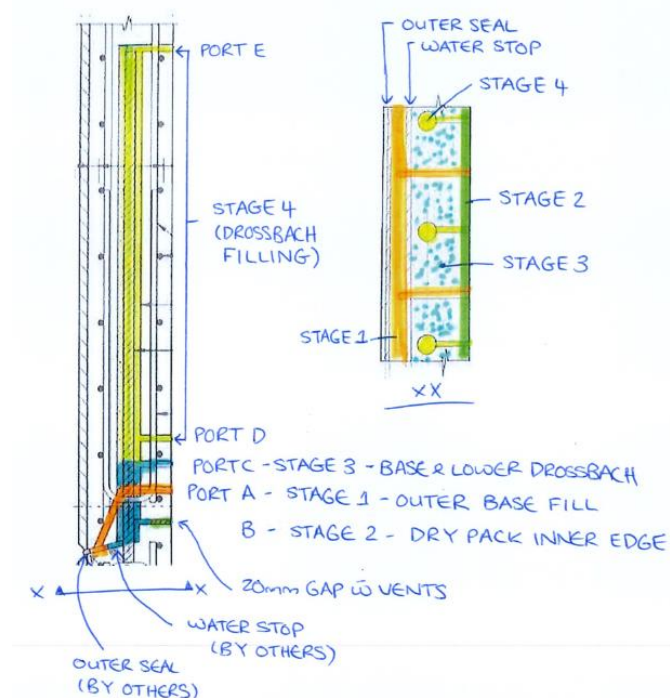
Figure 1: Diagram showing stages of grouting methodology

**Stage 1:** Grout between sealed outside panel edge and water stop by injecting via port ‘A’ (refer Figure 1 above).

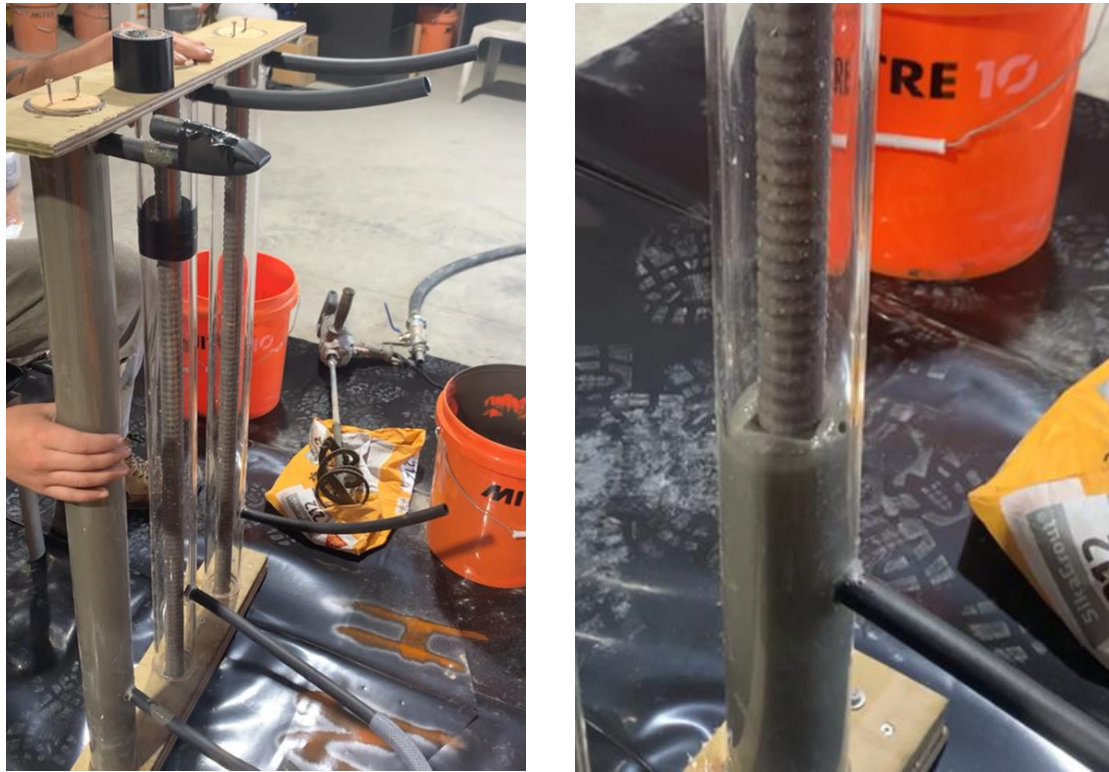
*Figure 3: Grout flow rate test setup with Perspex tubes*

As noted above, grout flow rate is an important parameter to control during the grouting process. The grout pump used by the grouting Subcontractor to fill the Drossbach ducts had variable speed settings, producing grout flow rates of 3 - 5.75 L/min. It was speculated whether higher flow rates had the potential to cause air entrapment within the grout mix, resulting in reduced grout quality. To assess this potential effect, a test setup was created to observe the Drossbach duct filling process at the 'low', 'medium' and 'high' speed settings. Perspex tubes were used to simulate Drossbach ducts, with starter bars placed inside and the tubes then filled in accordance with the project grouting methodology. The transparent nature of the Perspex tubes allowed the grout behaviour to be examined throughout the entire filling process (refer Figure 3 below). Whilst there were no major concerns with any of the tested grout flow rates, it was found that pumping at the 'medium' speed setting (~4 - 5L/min) was optimal to prevent air bubbles forming in the injected grout. Although the smooth inside surface of the Perspex tubes did not exactly imitate the corrugations on the inside of the Drossbach ducts, the likelihood of air-related defects forming due to turbulence / mixing effects caused by these corrugations was deemed to be low for the range of grout flow rates being used.

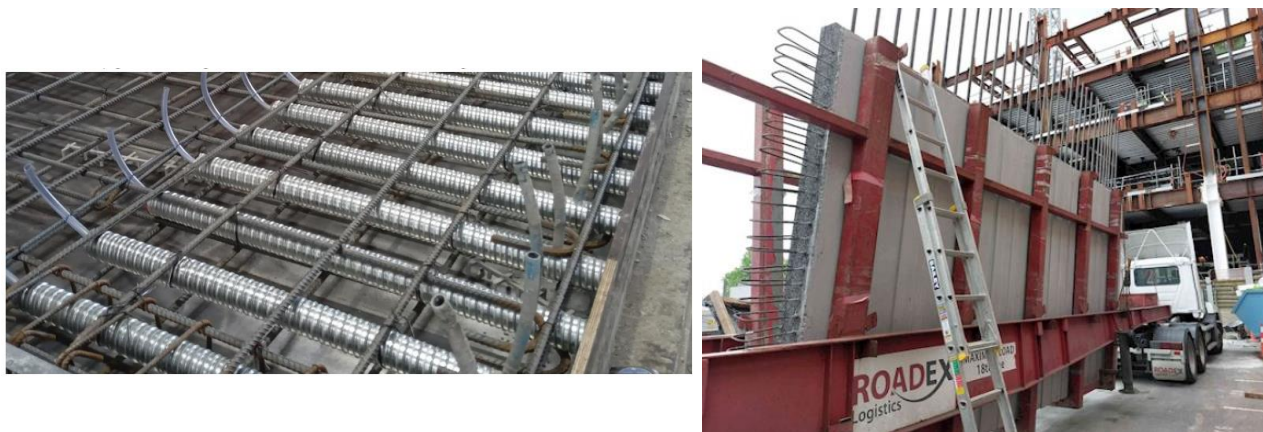
*Figure 6: Panel mould prior to casting and arriving on site*

QA/QC procedures commenced with a thorough review of the precast panel shop drawings by both the Main Contractor and Beca Engineering team. Once panels were ready for casting, detailed pre-pour check sheets were completed by the precast concrete Subcontractor. This included ensuring that the diameter and length of the Drossbach ducts were correct, with the set out and alignment of both the Drossbach ducts and starter bars then checked against the required construction tolerances. The considerable length of the starter bars meant that the plumbness of all elements forming the grouted Drossbach duct connections was critical to allow smooth site installation of the panels. Checks were undertaken to ensure the entry and exit grout tubes were installed and sealed correctly, without blockages or kinks that could later restrict grout flow. Maintaining the cleanliness of the inside of the Drossbach ducts during panel casting was extremely important, with hardened concrete residue and other debris potentially obstructing the path of starter bars into the Drossbach ducts during subsequent panel installation. As a QC measure, the Main Contractor reviewed all pre-pour QA documentation produced by the precast concrete Subcontractor, and would regularly visit the precast yard to conduct pre-pour inspections of their own. The Beca Engineering team also conducted independent reviews of a sample of the pre-pour QA documentation, as well as undertaking a number of visits to the precast yard for independent pre-pour inspections.
