Development of LSN-based pipe repair rate models utilising data from the 2011 Christchurch earthquakes

J.M. Moratalla & V.K. Sadashiva

GNS Science, Lower Hutt.

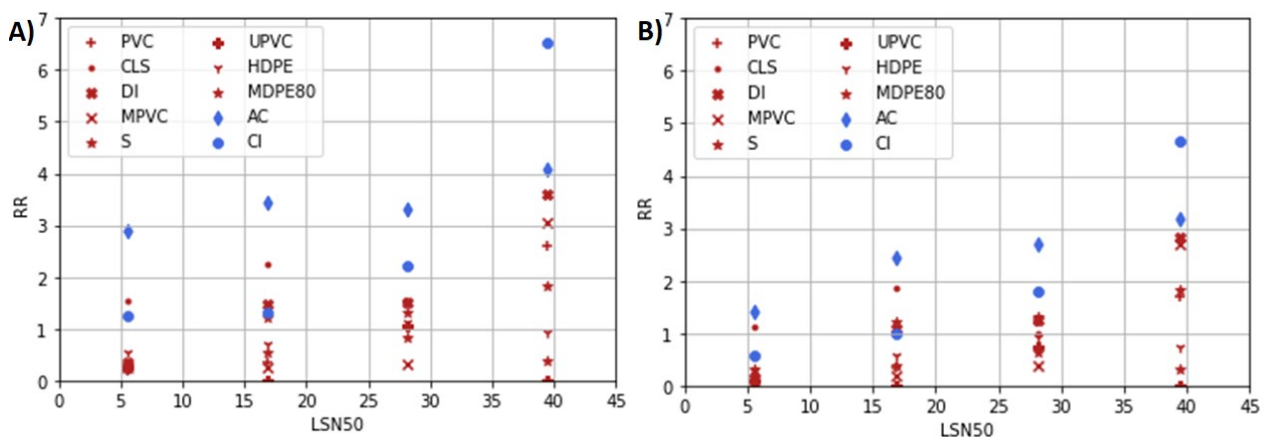
Figure 3: Mean repair rates vs. LSN using: A) 22 February 2011 event dataset; B) 22 February and 13 June 2011 event combined dataset. Ductile and non-ductile materials are respectively shown in red and blue.

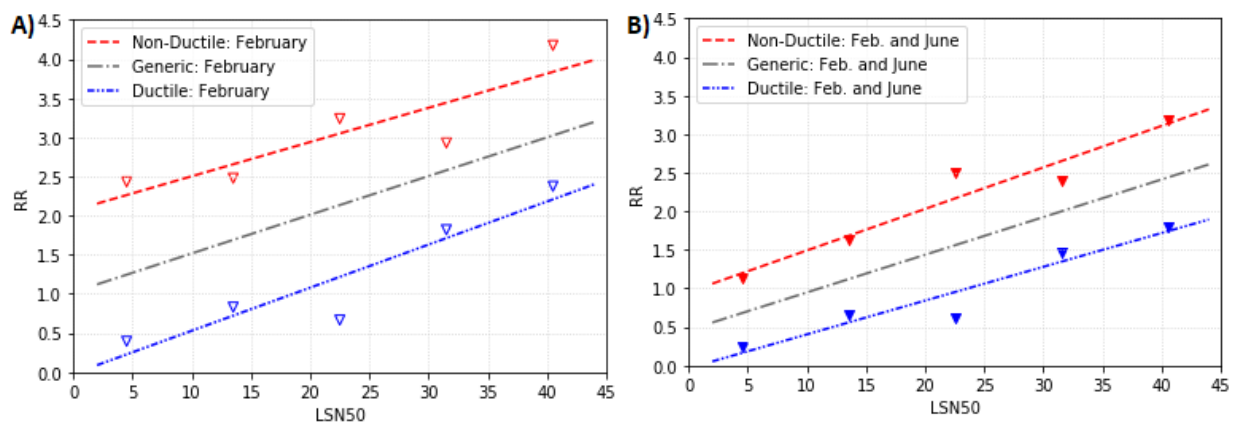
Figure 4: Repair Rate (RR) models for pipes of diameters $\geq 75\text{mm}$ using: A) 22 February 2011 event dataset; B) 22 February and 13 June 2011 events combined dataset. Triangles represent the data points used in the regressions.

Prior to developing RR models for pipes of specific material, RR models for pipes grouped by combination of diameter (i.e. $\phi < 75\text{mm}$ or $\phi \geq 75\text{mm}$) and material type (i.e. ductile or non-ductile, see Table 1) were derived. A large proportion of non-ductile pipes of diameter less than 75mm in the network is represented by Galvanised Iron (GI) pipes. These pipes performed poorly during the earthquakes and had repair rates more than 10 times the mean repair rates of pipes of other materials. Therefore, GI pipes were excluded from the grouping and a separate class was created for them. Enough LSN-RR data points passed the screening criteria and became available for RR models for Ductile and Non-ductile pipes with $\phi \geq 75\text{mm}$, and for Ductile pipes with $\phi < 75\text{mm}$ (see Figures 4 and 5a). Repair rate models for GI pipes were also derived and are shown in Figure 5b.

In addition to the above, a ‘generic’ repair rate model was derived from combining all material types except GI pipes in the $\phi \geq 75\text{mm}$ group dataset. This model (shown in Figure 4) can potentially be useful to estimate repair rate in cases where no information on the pipe material is available for pipe damage modelling. To avoid bias due to differences in lengths of different materials (i.e. avoid those materials with larger total lengths to have more weight in the generic equation), this model was derived using the weighted mean data-pairs calculated for the ductile and non-ductile material groups. The general form of the repair rate models is shown by Equation 1. The value of the parameters a_0 and b_0 , and the standard deviation of the residuals (σ_m) for each model is provided in Table 3.

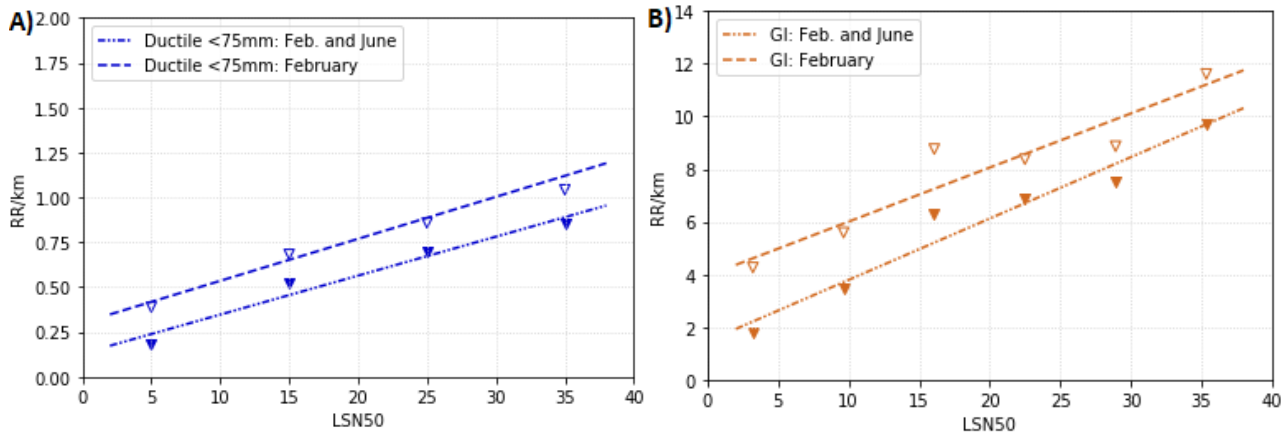
Figure 5: Repair Rate (RR) models for pipes of diameters $< 75\text{mm}$: A) Ductile pipes; B) Galvanised Iron pipes

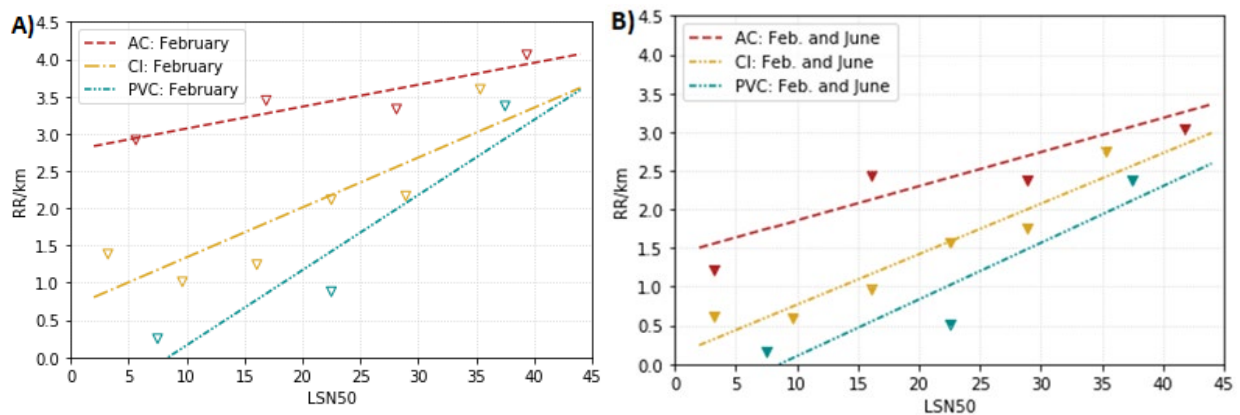
Figure 6: Repair Rate (RR) models for AC, CI and PVC material pipes of diameter $\geq 75\text{mm}$ using: A) February event dataset; B) February and June events combined.

The general form of the corrected repair rate model Equation 2. The correction factors are included in table 4, here a_1 and b_1 are the material-specific correction factors and a_0 and b_0 are the factors from Table 3. The repair rate models are shown in Figure 6 and Figure 7.

Among the non-ductile pipes of diameter $\geq 75\text{mm}$, the repair rate results in Figure 6 show AC pipes were more vulnerable to liquefaction effects than the CI pipes. The PVC pipes (ductile category) of diameter $\geq 75\text{mm}$ show lower repair rates than the AC and CI pipes. The above observation can be seen in results obtained using February dataset only, as well as when the February and June combined dataset is used. From the pipe group of diameters $< 75\text{mm}$ and made of ductile material, MDPE80 pipes show lower repair rates than pipes of HDPE material (see Figure 7).
